FORCE BLUE

Summary Report of Preliminary Enquiry

Date of incident: **24 April 2008 at 07:25h (local time)**

Type of incident: **Accident to person (fall from height)**

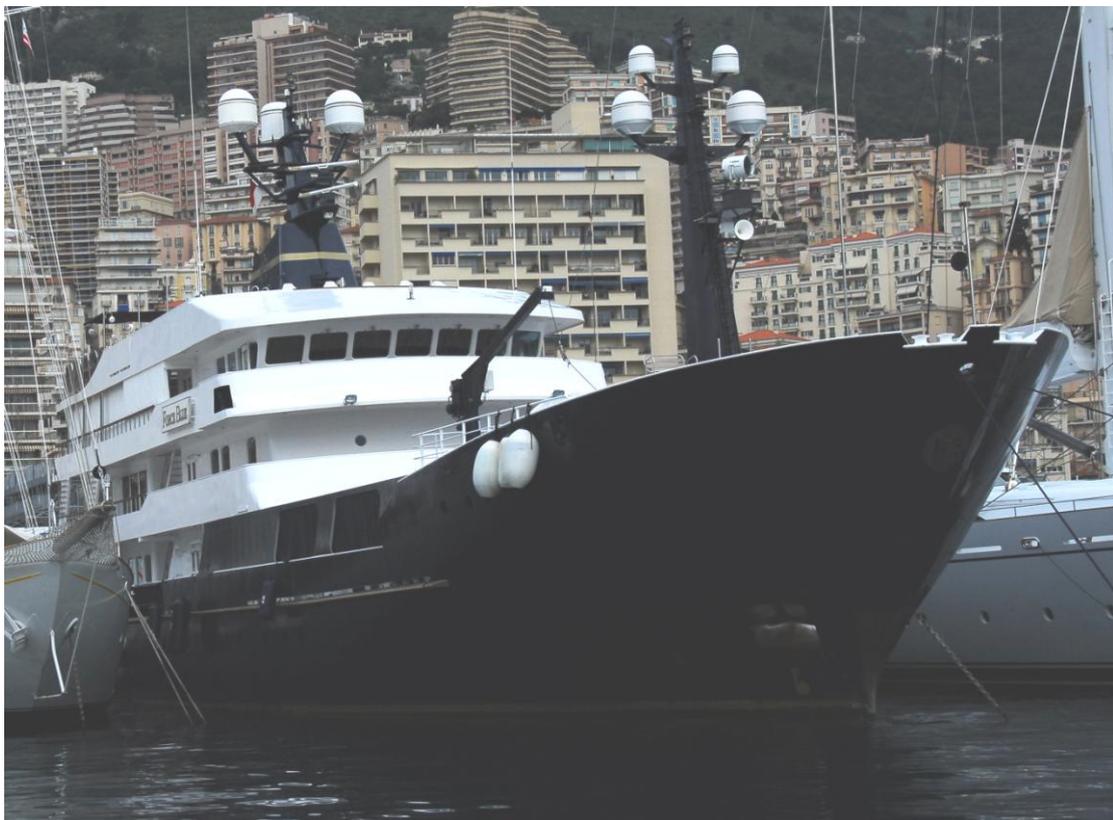
The deckhand reported hearing a cry and when he went to investigate discovered that the second officer had fallen from the sun deck and had landed on a protective metal cage around a pipe in the quayside (Figure 6), a vertical distance of approximately 12m (Figure 2).

Figure 2
View of height from wheelhouse top to waterline.(approximately 12m)

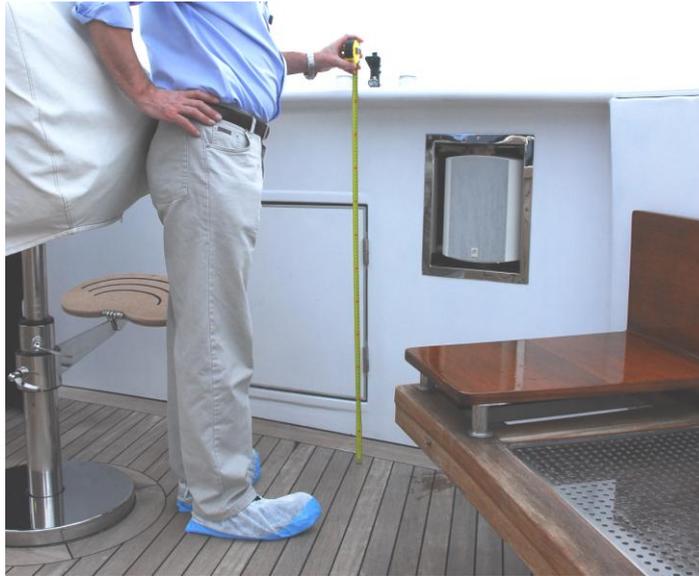
It is likely that the second officer made use of the foot rests on the observation chairs at the front of the sun deck (Figure 4) to increase his reach when using the mop. This would have reduced the effective height of the forward bulwark to 0.66m. It is likely that, when in this position, the second officer lost his footing and fell over the bulwark onto the sloping bridge top and over the starboard side of the vessel.

Figure 3
Forward bulwark on wheelhouse top. (1.145m height)

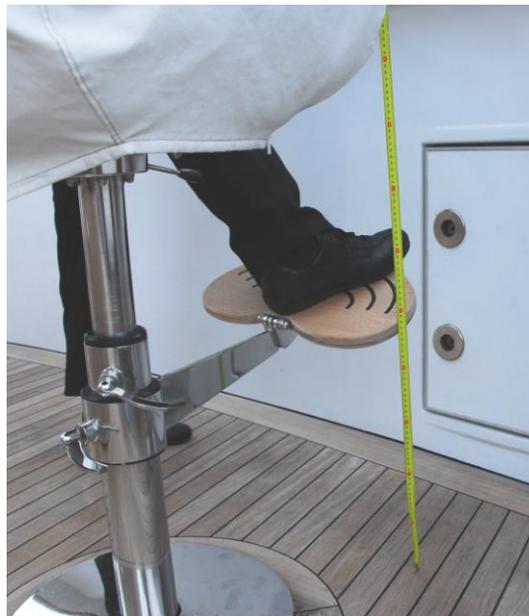
Figure 4
Step that may have been used to increase reach. (0.485m height)

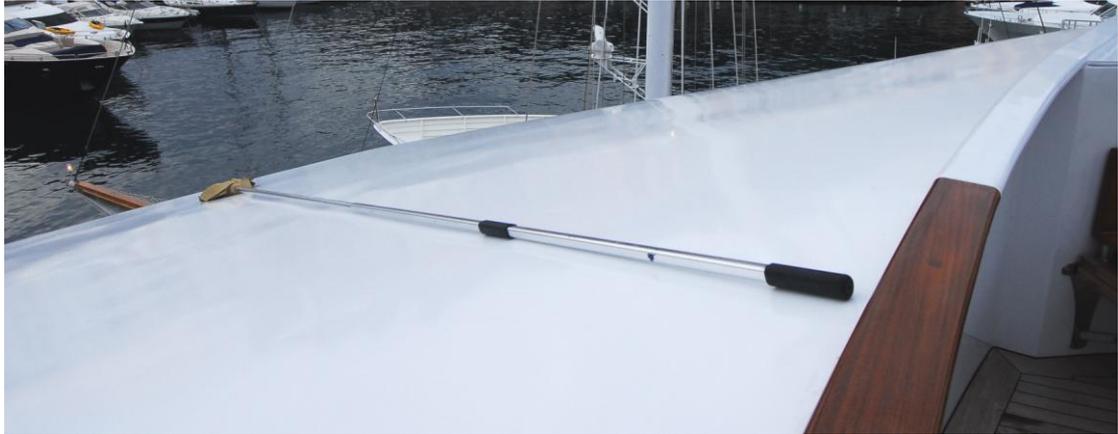
In order to wipe down or wash the sloping bridge top an extendible mop is provided. Fully extended this mop is 4.3m in length which is not quite long enough to reach the extremity of the sloping bridge top without leaning over the bulwark (see Figure 5).

Figure 5
Extending mop used to clean wheelhouse top (3.4m length)

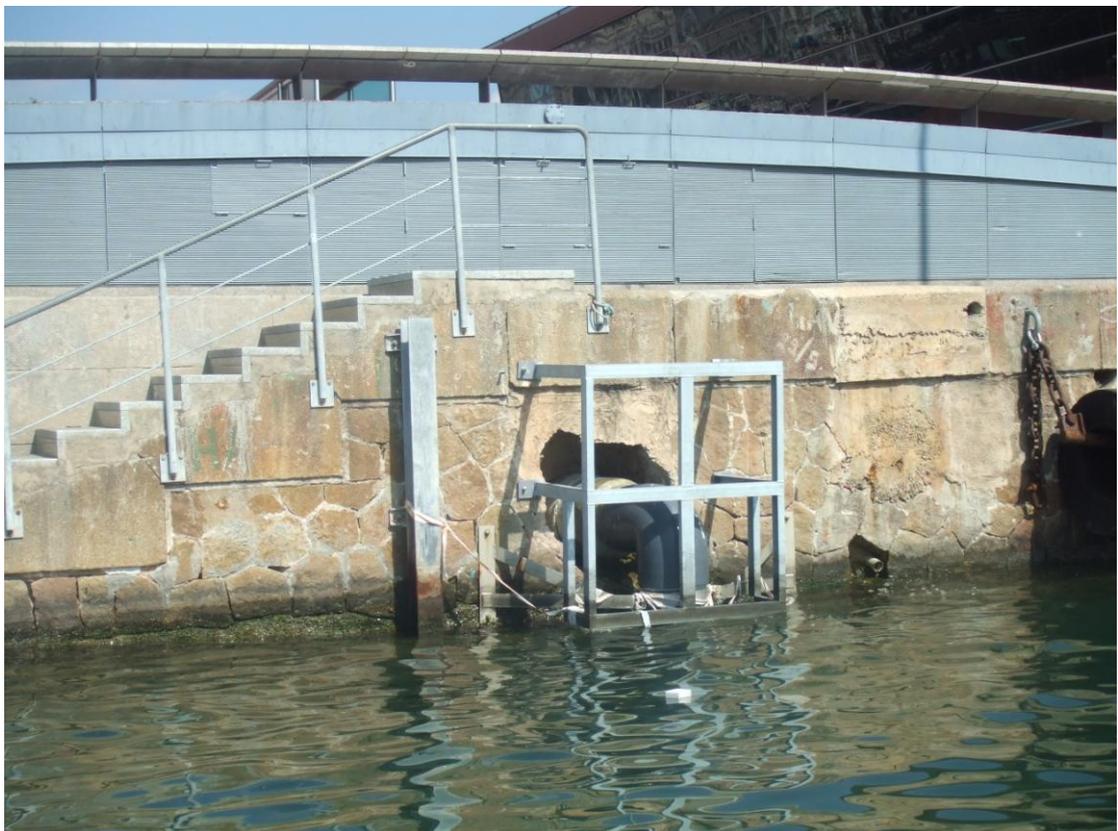
Figure 6
Protective cage which prevented the second officer entering the water.
