**Interim Report of the investigation of  
the accident resulting in one fatality  
during maintenance operations on board the commercial yacht**

**ONE MORE TOY**

**in Saint Barthelemy  
on 14 January 2020.**

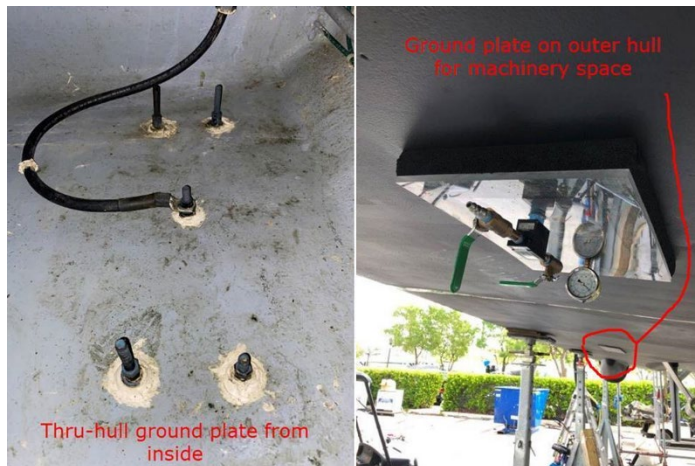
Fig 1: Hull Earth / Ground Plate (Courtesy of American Bureau of Shipping)

As the hull of the yacht is constructed from non-electrically conductive GRP, the exposed conductive parts of equipment are physically bonded to the switchboard earth. There is no direct path for any fault current to return to the earth / neutral in the switchboard or the hull earth plate via the yacht's hull.

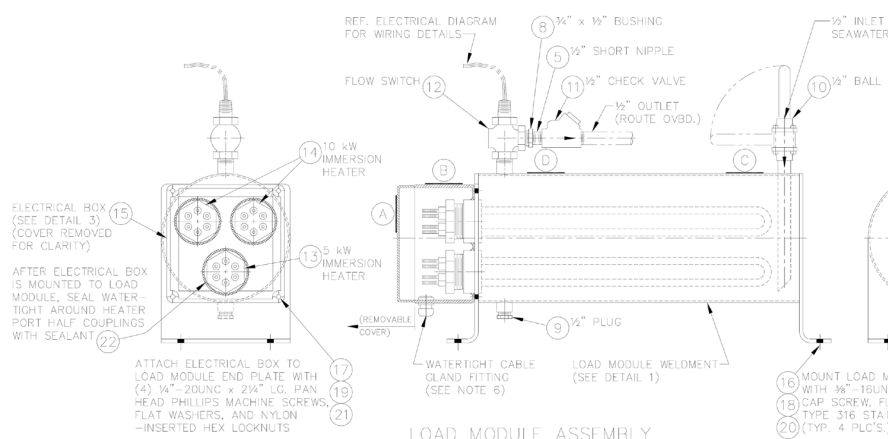
Fig 4: Generator Load Bank

The yacht’s maintenance records show a history of problems with the load bank dating back to 2006. Included in the records are an invoice for extensive work on the unit carried out in January 2016 and a second invoice for “investigative work” in April 2019. The load bank was reported as out of service when the Engineer joined the yacht and the regular engineer did not use the load bank, preferring instead to manage the load on the generators manually.

It is probable that the Engineer died as a result of an electrical fault in the load bank such that there was an electrical path between the heating elements of the load bank and its casing.

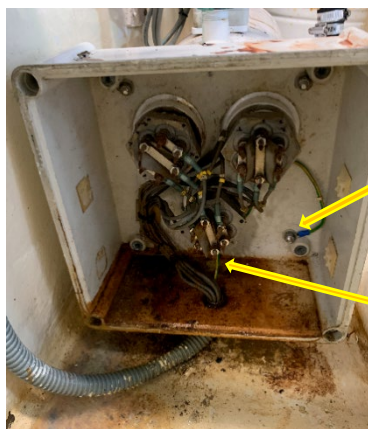
During his time on board, the Engineer made five entries in the PMS relating to the load bank. The first of these entries was dated 15 December 2019 and the final entry was dated 11 January 2020. The 15 December entry that noted water ingress in the load bank electrical junction box had occurred in the past and that the Engineer was expecting to encounter problems with the heating elements.

Fig 5: Generator load bank electrical junction box showing signs of previous water ingress. Also shown is the earth connection (green / yellow wire) between the load bank casing and the yachts earth bus bar.

The mechanical connection between the load bank casing and its earth connection was not effective in providing electrical continuity to a "true earth".

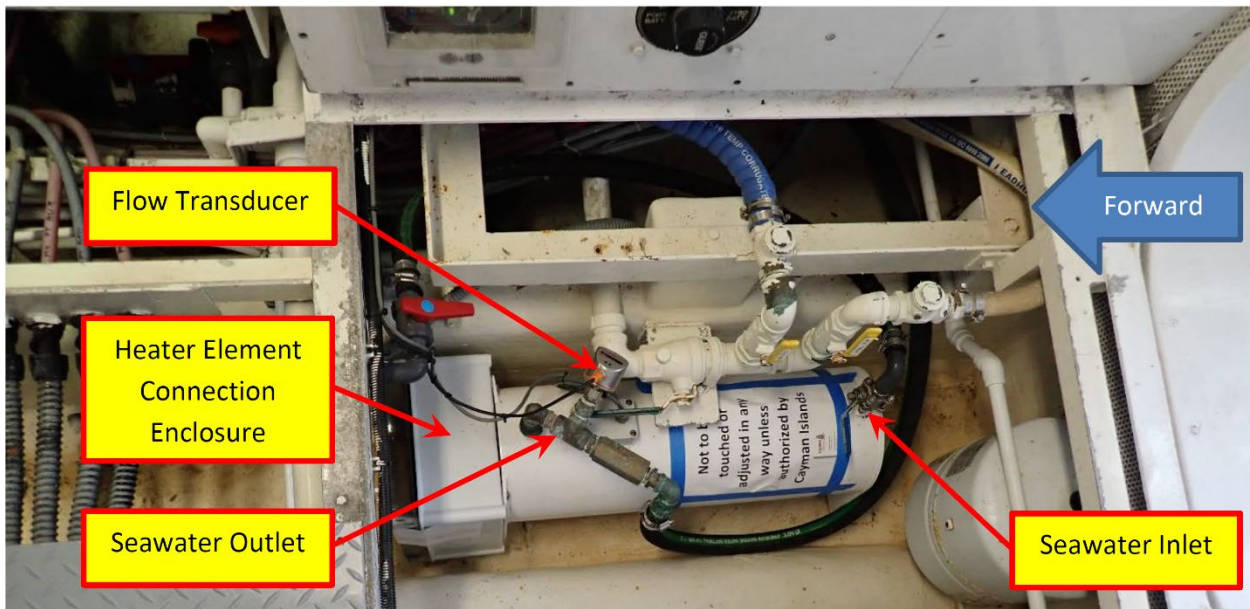
Fig 6: Generator Load Bank in situ (from 01 April 2020 electrical tests)

- When energising one of the load bank elements an electrical arc was observed between the load bank earth connection termination and the casing of the load bank. (Jan 20)

- Smoke marks were observed at the termination of the load bank earthing connection at the load bank casing following the above test. (Jan 20)(Apr 20)
- After the observed arcing and subsequent smoke marking at the load bank earthing connection (and after the electrical isolation of the load bank) the resistance between the load bank earth connection and a "true earth" was measured at 0.2 Ohm. (Jan 20)

- Continuity testing between the load bank earthing connection and the load bank casing recorded a resistance in excess of 100,000 Ohm. (Apr 20)
- 500-volt DC<sup>4</sup> insulation resistance tests with an Extech Instruments Digital Megohmmeter showed electrical insulation failures between all of the three heater elements and the load bank canister. (Apr 20)
