**Report of the investigation of
the fatality onboard the chemical tanker**

STOLT HELLULAND

**in Houston, Texas
on 13 January 2008.**

Casualty 01/2008

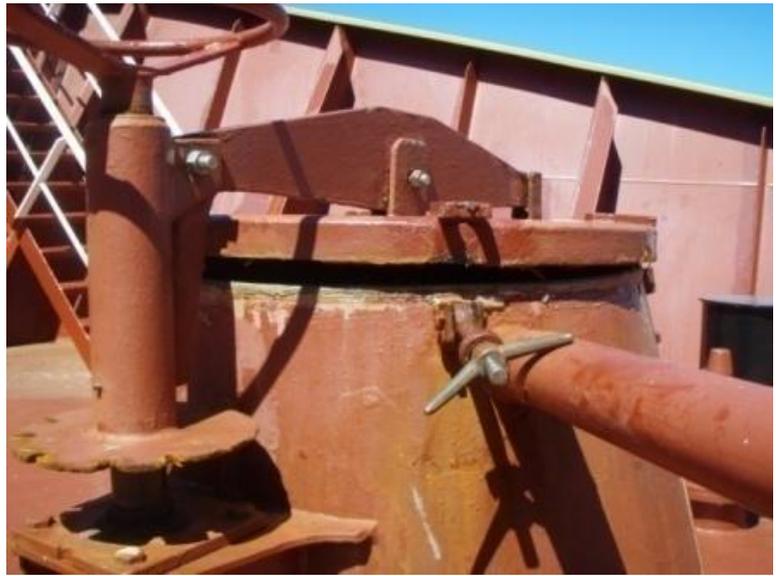
Figure 2: 2 Stb Ullage hatch partially open for atmospheric sampling

At 0645 the third officer announced that he was going to check the oxygen level in 2 *Stb* and left the CCR and proceeded onto the deck. This operation involves passing a sample tube attached to an oxygen analyser (Figure 3) about 1 ½ meters into the tank and sampling the atmosphere. The tube is passed through the gap in a partially open ullage hatch (Figures 1 and 2).

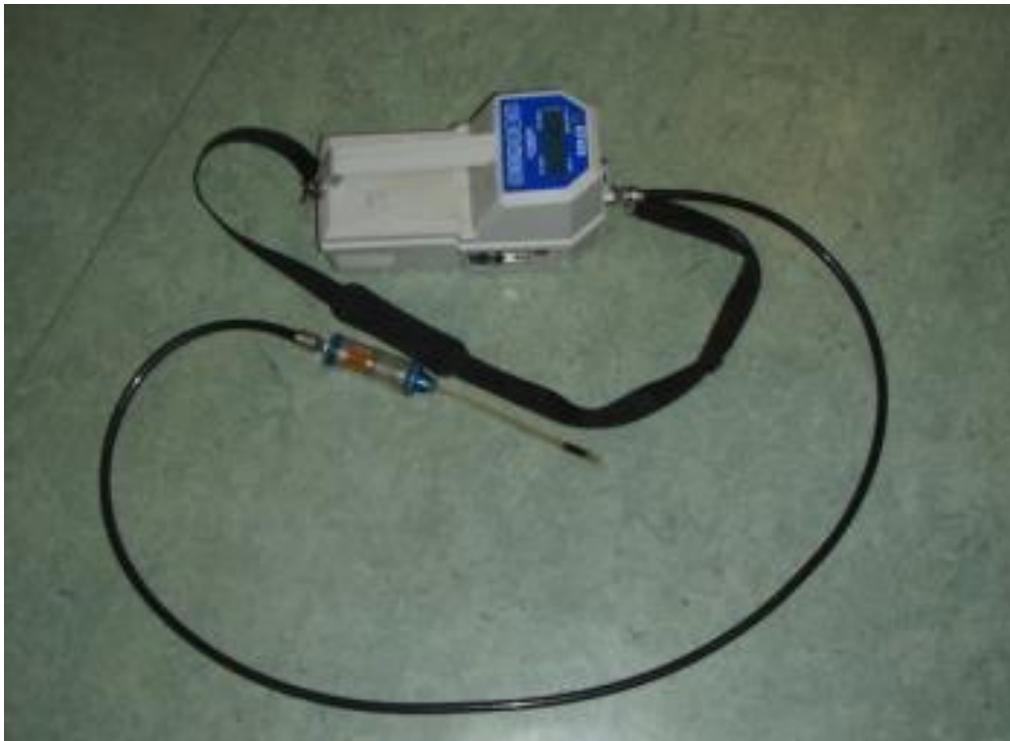
Figure 3: Oxygen analyser similar to that used by the third officer

When the third officer was discovered unconscious in *2 Stb*, part of the oxygen analyser sample tube and water trap were also found in at the bottom of the tank. It seems likely that these parts of the analyser fell into the tank and the third officer was attempting to retrieve them when he was overcome by the oxygen deficient atmosphere. Before entering the tank, the third officer went to the deck store for a filter mask which he was wearing when found in the tank.

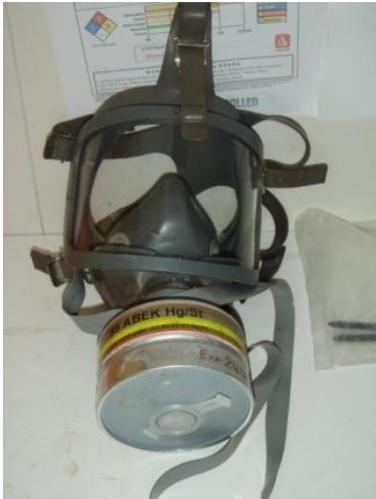
Figure 4: Filter mask, or air purifying respirator, of the type worn by the third officer when he entered the tank,

The filter mask was rated for A2³, B2⁴, E2⁵, K1⁶ and Hg-P3⁷ applications under EN14387:2004⁸. However, respiratory protection with filter masks is dependent on the ambient air containing sufficient oxygen to sustain life. They give no protection whatsoever in an oxygen deficient atmosphere such as was present in *2 Stb* at the time of the accident.

The third officer may have confused “oxygen deficient” and “toxic” and believed protection against one hazard would offer protection against the other. This confusion may have led the third officer to believe that a filter mask for toxic vapours would offer protection against an oxygen deficient atmosphere.

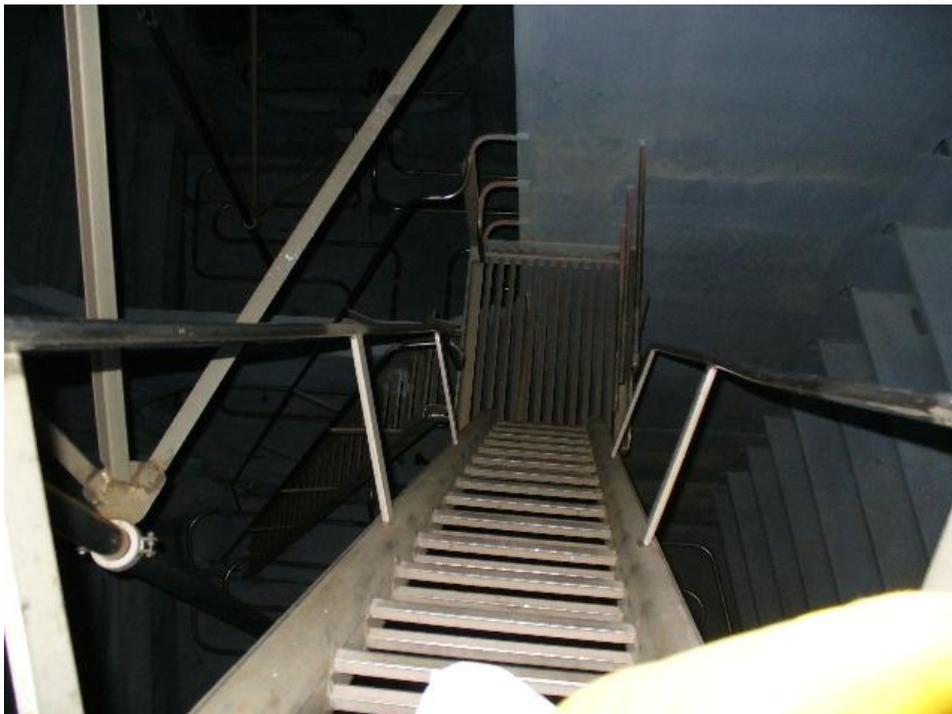
Figure 5: Interior of 2 Stb cargo tank.

At the time the third officer went to sample the atmosphere in No 2 Starboard the atmosphere could be expected to contain approximately 8% - 10% oxygen. This level of oxygen is insufficient to sustain life and will quickly disable anyone exposed to this atmosphere.

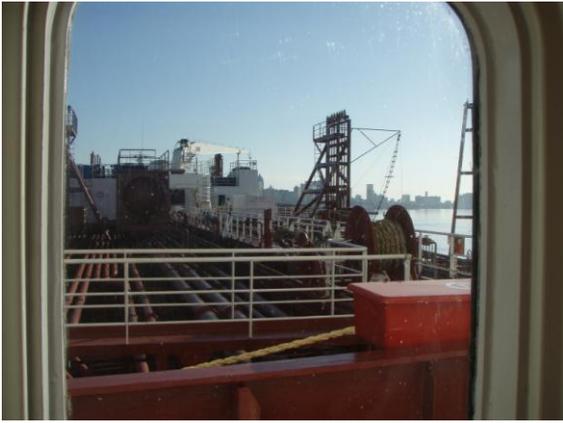
View from CCR (2 Stb unsighted)

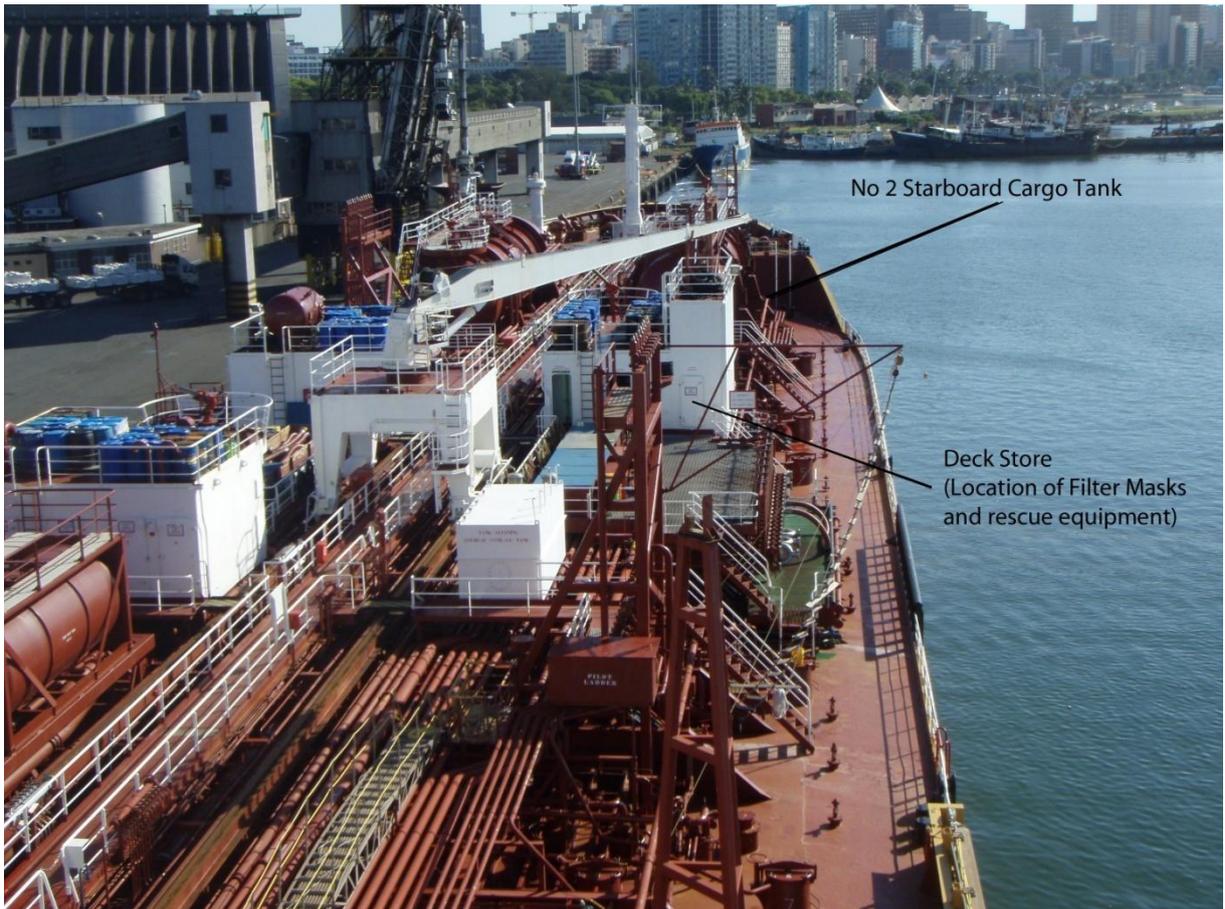
View from Stb Bridge Wing (2 Stb unsighted and deck store location)
