**Report of the investigation into
the accident resulting in one fatality on board the chemical tanker**

STOLT SKUA

in the North Sea on 15 April 2012.

Maritime Authority of the Cayman Islands
Government Administration Building
133, Elgin Avenue
PO Box 2256, George Town
Cayman Islands
KY1-1104

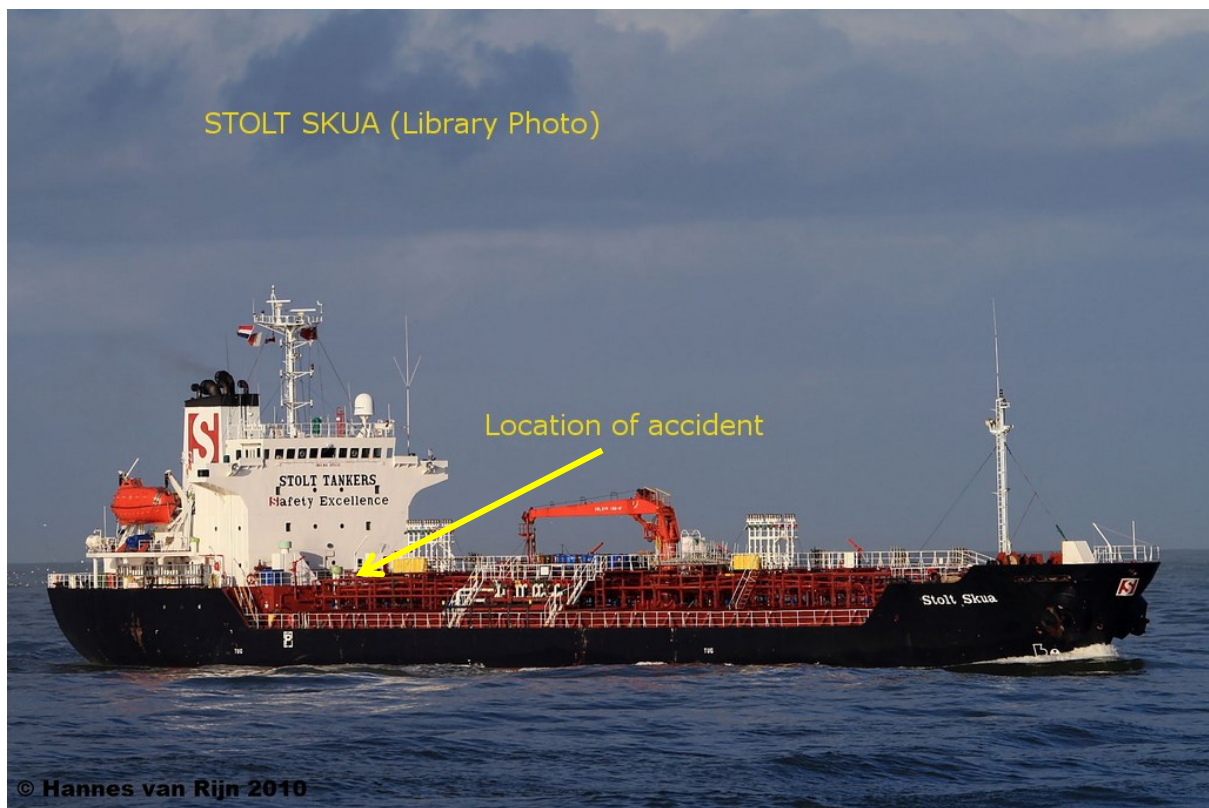
- A) The primary cause of this accident was the OS's decision to enter cargo tank 10 S which contained a toxic and oxygen deficient atmosphere incapable of sustaining life.

Library photo of STOLT SKUA showing location of “10 S” where the accident occurred.

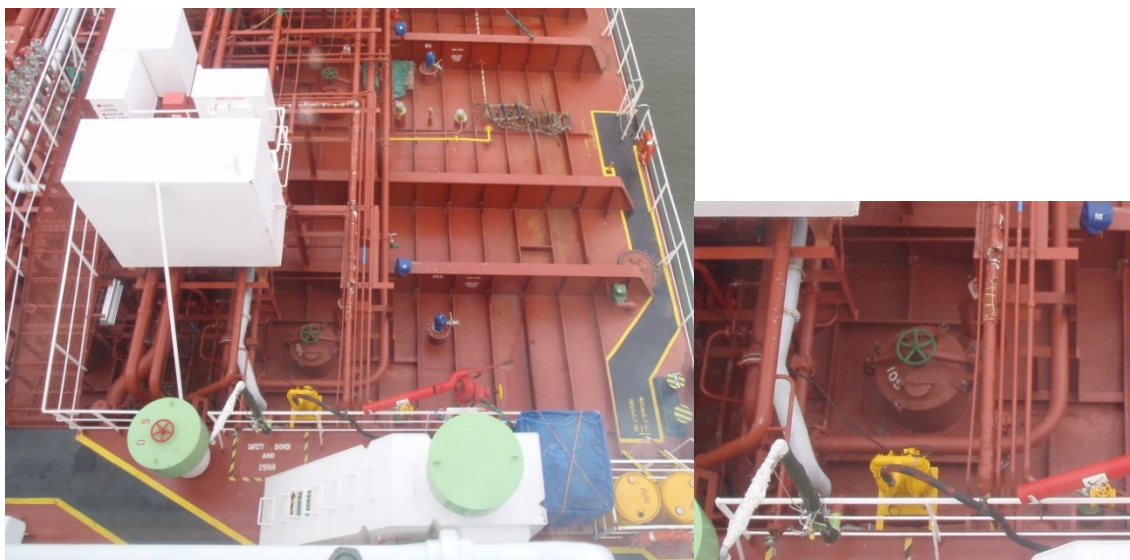
While walking from the cargo manifold towards the ship's accommodation, the Pumpman noticed that the main hatch for tank number 10S was open and the hoses for the Wilden Pump were leading into the tank. He also heard the Wilden Pump running inside the tank. As ventilation of this tank had not been completed, it was too early in the tank cleaning process for the Wilden Pump to be used to eject any remaining tank washings. The Pumpman went to investigate and discovered the OS laying apparently unconscious on the first platform inside the tank. When discovered, the OS was wearing one of the filter masks issued earlier in the day by the Chief Officer. The time was 08:58LT.

View from the navigation bridge showing the hatch for “10S”

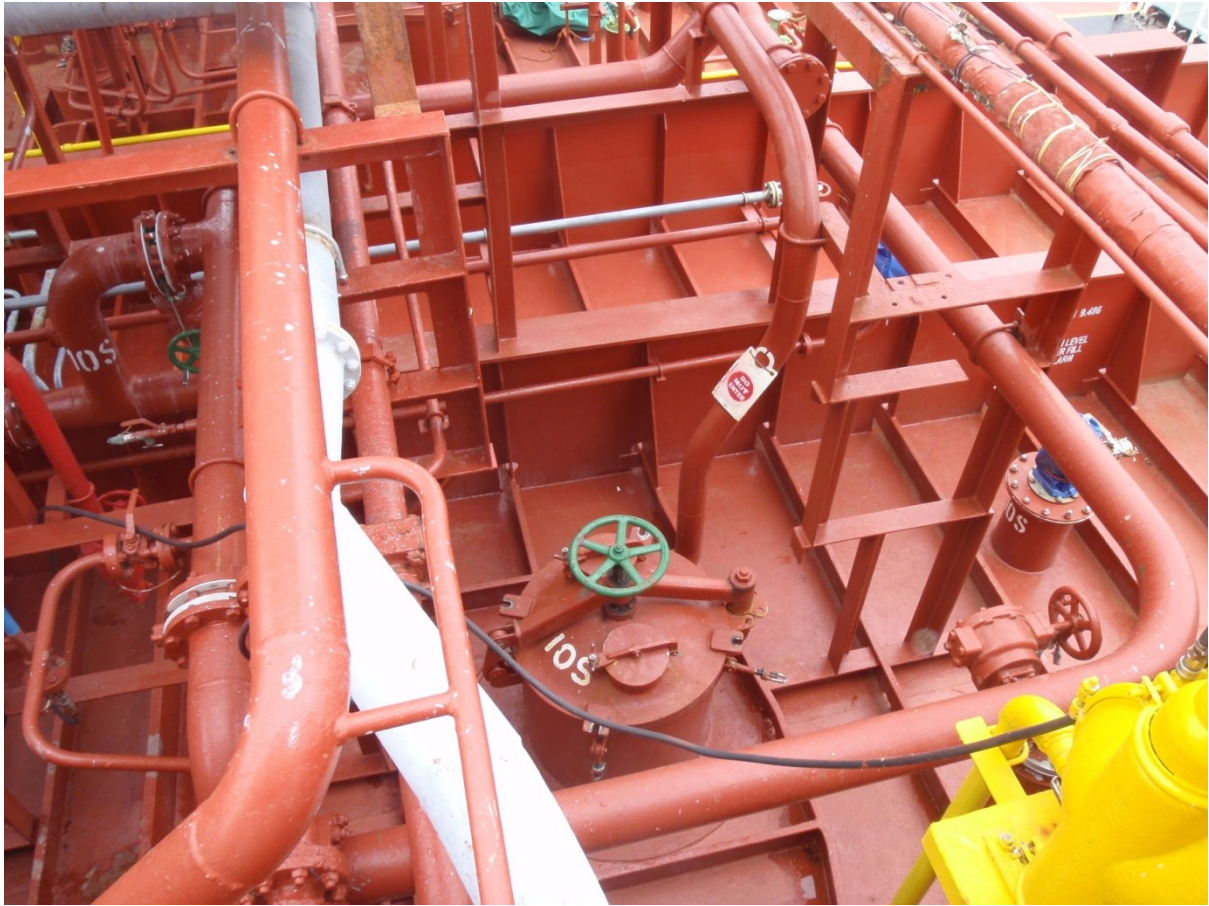
Area around the tank entrance

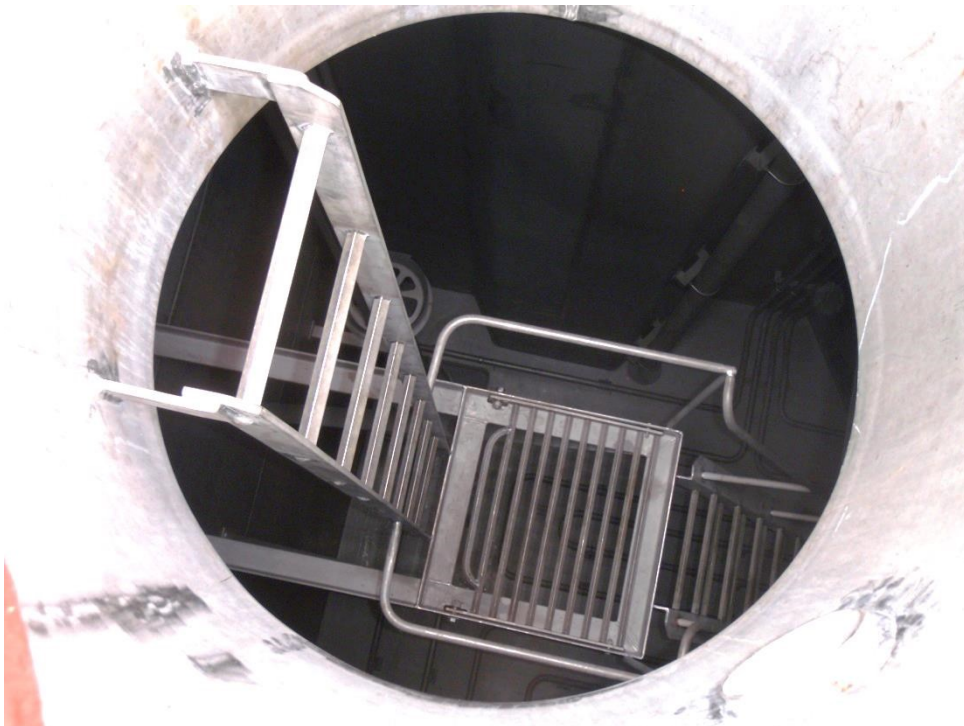
The Post Mortem conducted on the OS showed no evidence of him falling into the tank from the deck onto the first platform on which he was found (a height of 3.31m). It is therefore concluded that he climbed into the tank and down the ladder onto the first platform. The most likely reason for him to take such a course of action is that he was attempting to move the Wilden Pump to a new location in the tank after it had become caught in the tank’s internal structure.

View inside tank showing the “first platform” where the OS was found unconscious.

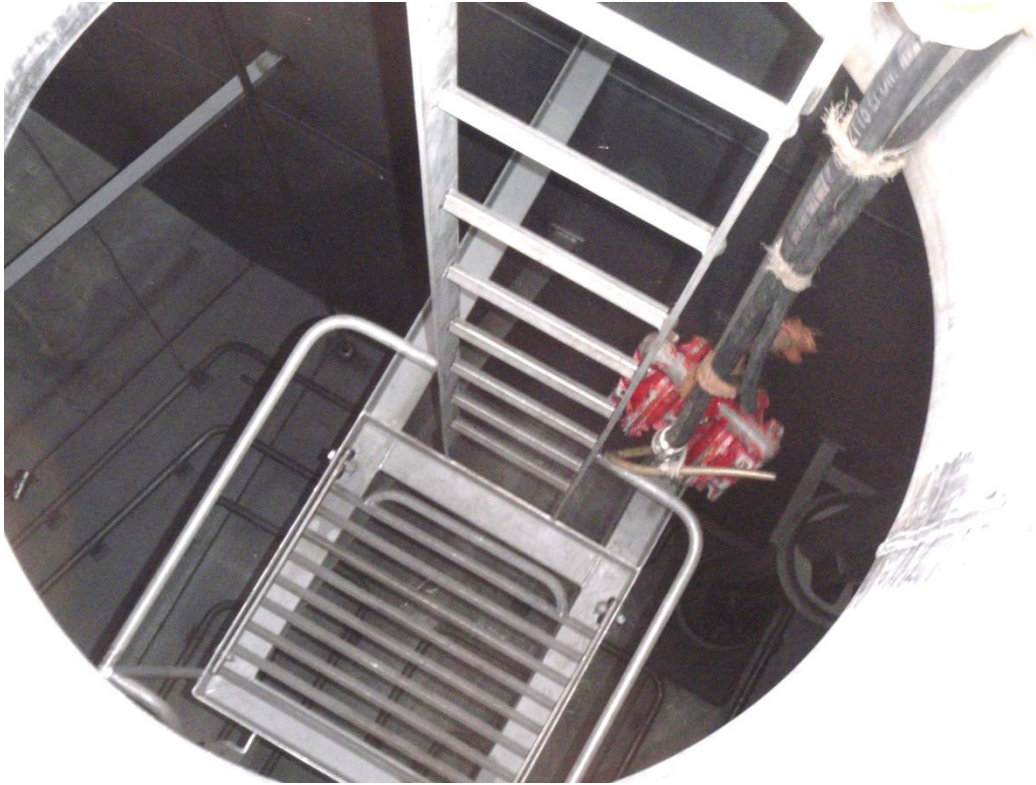
Rather than waiting for the atmosphere in the tank to be confirmed as safe, the “Optimising Violation” was to lower the Wilden Pump into the tank before the atmosphere had been checked, with the seafarer remaining on deck and not entering the tank. It was not possible to determine if this practice had become the norm on board STOLT SKUA or if it was employed only in certain circumstances. It was also not possible to determine if the practice was undertaken with the knowledge and approval of the Chief Officer. However, it is clear that this deviation from the standard tank cleaning procedure was being employed on the day of the accident.

Lowering a “Wilden Pump” into the cargo tank to eject any remaining tank washings.
