## **URGENT SAFETY RECOMMENDATIONS**

### **FLYER TO THE YACHTING INDUSTRY (01/2025)**

#### **Shell Doors in Yacht Hulls.**

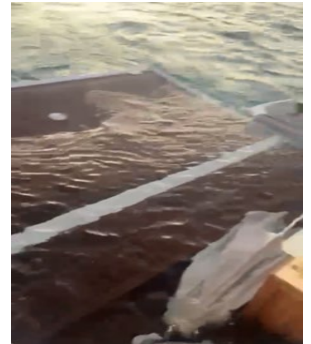
The Cayman Islands Shipping Registry (CISR) is aware of a sudden swamping of a vessel through the open shell doors during the recovery of a personal watercraft (PWC). The transom and port side doors were open at the time of the recovery operation which was taking place in the early evening after the day's watersports activities. The conditions at the time of the recovery were described as near flat calm but the vessel is known to have taken on a port list during recovery operations as reported by the crew.

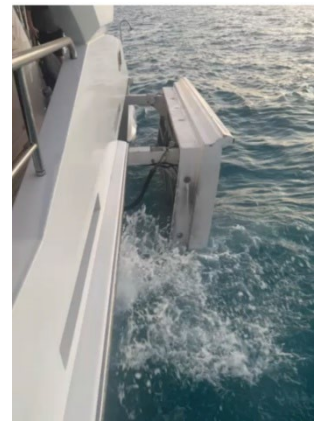
During the recovery operation the vessel was hit by three large waves (larger than they were experiencing at the time) of unknown origin, which resulted in significant water ingress. The water ingress led to progressive flooding in all bilges and spaces aft of the Engine Room and the vessel taking on a 10-degree port list. The water ingress also led to failure of the hydraulic systems and consequently the doors could not be closed.

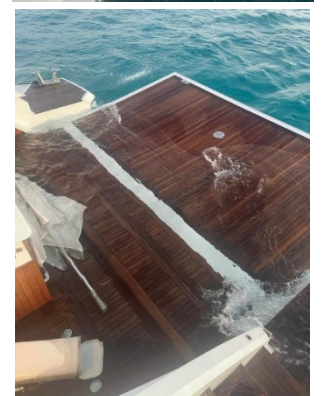
The vessel's main bilge pump was also not able to keep up with water ingress and fearing for the vessel's safety the Master elected to beach the vessel to prevent the vessel from suffering from a further loss of stability. The vessel had guests on at the time and fortunately all guests were safely relocated to shore and there were no injuries reported to any persons on board. The vessel was beached on to soft sand and there was no pollution or environmental damage. But for the quick actions of the Master the incident could have resulted in a serious marine casualty potentially leading to capsize or foundering of the vessel.
