# CAYMAN ISLANDS SHIPPING REGISTRY

## FLYER TO THE LARGE YACHT INDUSTRY

### Fatal accident during bridge transit.

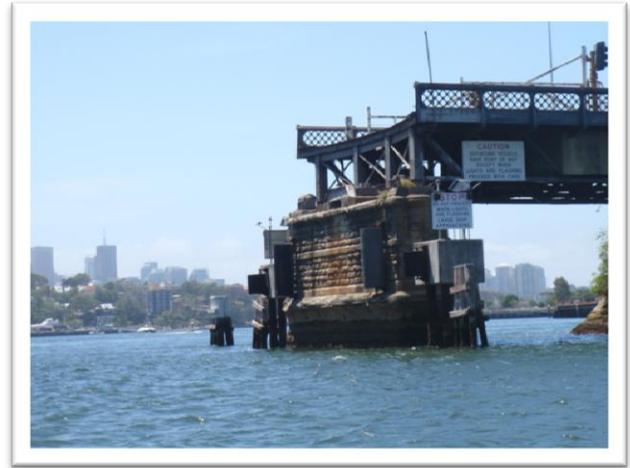
Eastern Buttress of the Swing Bridge

Shortly after leaving the marina it was necessary for the yacht to transit a disused swing bridge at Glebe Island. When passing through the bridge, the yacht passed close to the eastern buttress of the bridge requiring the crew to manually “fend off” by placing fenders between the yacht’s hull and the eastern bridge buttress.

While placing one of the yacht’s fenders, a crew member was apparently struck by a fixed fender attached to the bridge structure and pulled over the side of the yacht. The crew member was caught between the bridge structure and the hull of the yacht as it passed through the bridge and sustained severe crushing injuries. Once clear of the yacht’s hull, the crew member fell to the water. The crewmember was retrieved from the water by a small boat that was in the vicinity of the Glebe Island Bridge at the time of the accident. When the crew member was retrieved there were no apparent signs of life and the crew member was pronounced dead shortly after.

- **Passage Planning**

Proper passage planning is an essential exercise in identifying risk and putting suitable mitigation measures in place. Even when the exact track for part of the voyage is not known in advance (e.g. a general “harbour cruise”), potential hazards should be identified and criteria such as minimum distance from shore, minimum under keel clearance, etc determined. Potential hazards and “no go” areas should be identified on navigational charts to be used for the intended voyage.

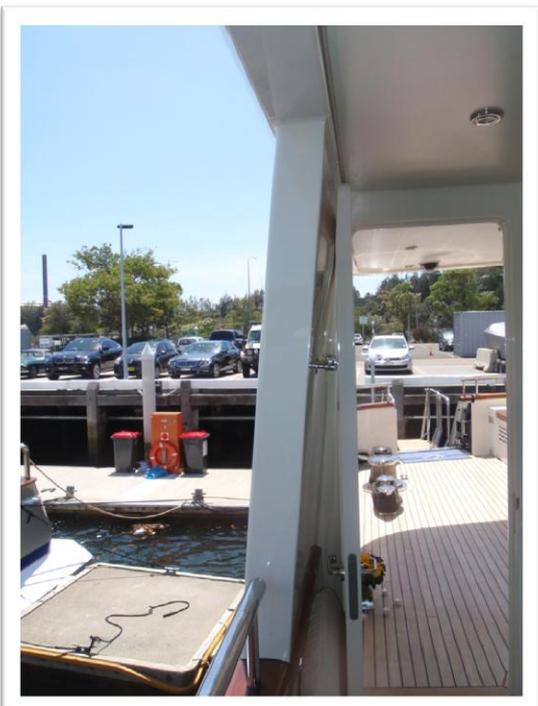
Note the lifebuoy in white cover behind door.

Life saving appliances, such as lifebuoys, should be readily available and highly visible to all crew members in an emergency. When an emergency situation occurs, crew members are often under extreme stress and the location of suitable life saving appliances should be immediately obvious. The use of white cosmetic lifebuoy covers to reduce their visual impact is never recommended, but if fitted, such covers should always be removed as part of the standard “pre departure activities” prior to any vessel leaving the relative safety of the dock.
