CAYMAN ISLANDS SHIPPING REGISTRY

FLYER TO THE LARGE YACHT INDUSTRY

Fatal accident while launching Personal Water Craft.

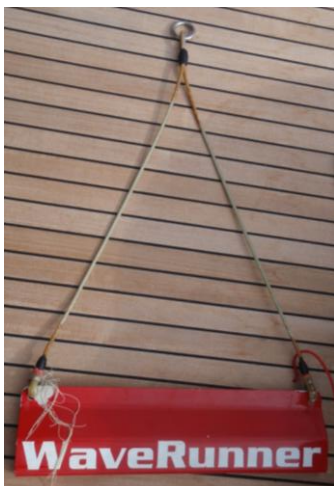
Sling and Spreader

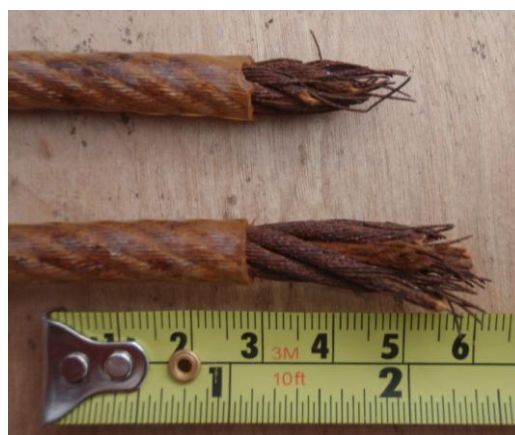
Upon inspection, the steel lifting slings in use were found to have failed in way of the crimped eye connection to the spreader beam. The slings were found to be heavily corroded and this corrosion had not been identified by the onboard maintenance and inspection regime. Further, the history and origin of the lifting sling was not readily apparent. It was stated that they were supplied with the PWC, but the model and manufacturer of the sling could not be identified and no manufacturer's documentation of certification could be located.

Failed slings

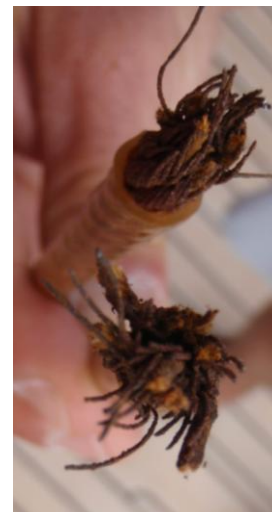
Corrosion of slings

- Loose gear should be visually inspected before each use and be integrated into the onboard maintenance, inspection and testing regime.
- Examinations of lifting appliances and loose gear should be carried out by persons competent, by virtue of their knowledge and experience, to do so.

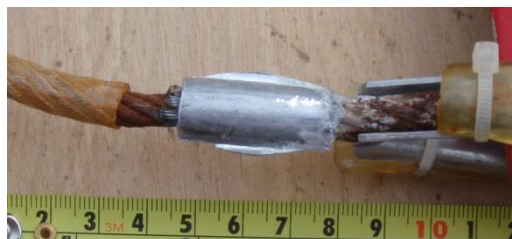
Tape removed

Sling failure

- When visually inspecting loose gear, sufficient areas under tape and other “protective coverings” should be inspected such that the overall condition of the loose gear can be assessed.
