Report on the preliminary investigation of
the engine room fire onboard

Ice Flake

10 August 2006

Casualty 2006 / 10

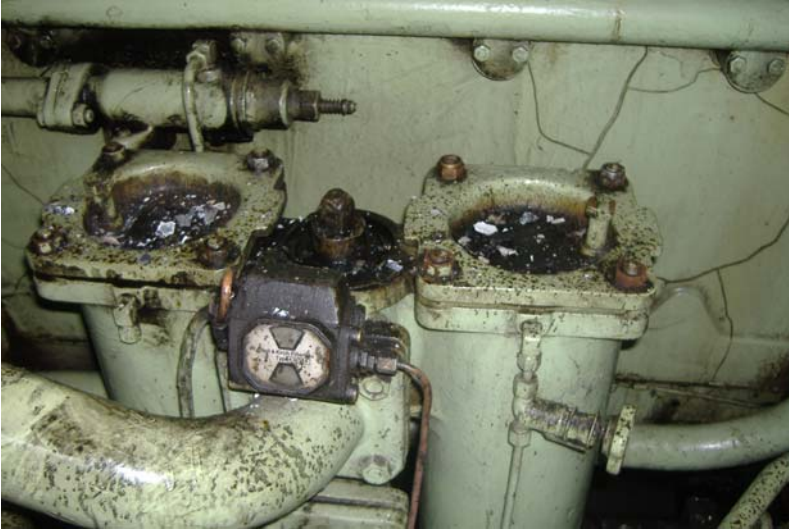
- 1 The fire was caused by the failure of a copper instrument line on a differential pressure gauge fitted to No 2 Generator. When this line failed, hot pressurized lube oil impinged on the hot exhaust surfaces of the generator and ignited. Lube oil from the fracture continued to supply fuel to the fire and it rapidly spread to other combustible material in the area. (See Appendix 1, Figure 1)

Figure 1: Showing a differential lube oil gauge and instrument lines similar to those which failed on No 2 Generator. Note that these instrument lines are also copper.

- (b) all vessels in their fleet to ensure Instrument lines carrying flammable fluids are fit for purpose and reasonable precautions (such as shielding) are in place to reduce the risk of failure leading to fire or explosion.

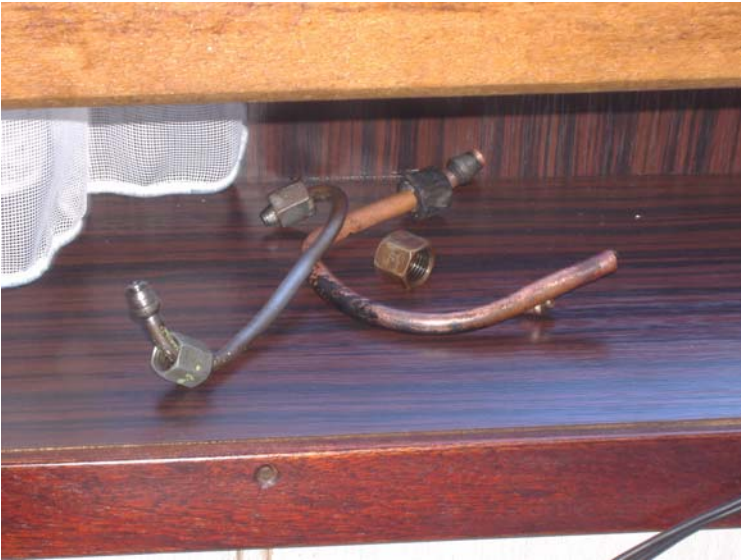
- 2 At some time in the past it appears that the steel instrument lines on some of these gauges had been changed to copper. Of the other similar installations on the generators some were found to be steel while others were copper. (See Appendix 1, Figure 2).

Figure 2: The copper instrument line which failed and an original steel instrument line removed from a similar gauge on Generator No 1.

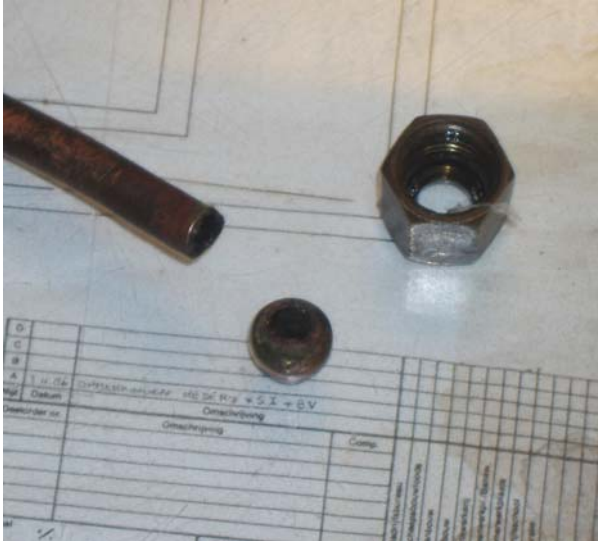
- 3 The compression fitting in way of the failure had been brazed to the instrument line. The heat input from this operation would have almost certainly changed the mechanical properties of the copper (strength, toughness, resistance to fatigue, etc). (See Appendix 1, Figure 3). This is seen as directly contributing to the failure.

Figure 3: Close up of the failure site. Note the brazing of the compression fitting to the instrument line.

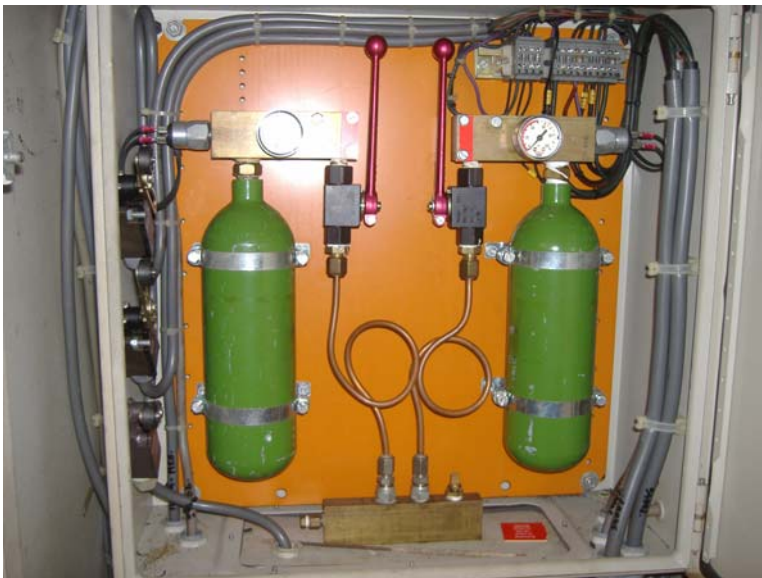
Halon is discharged by admitting CO₂ at a minimum pressure of 50 bar into pilot lines that run from the control station (Appendix 1, Figure 4) to the actuators on each Halon 1301 bottle located throughout the engine room. (The system onboard uses CO₂ at 70 bar) The manufacturer specifies that steel pilot lines are to be used for this purpose. (See Appendix 2)

Figure 4: CO₂ Pilot Cylinders (discharged) for release of Halon into the Engine Room.

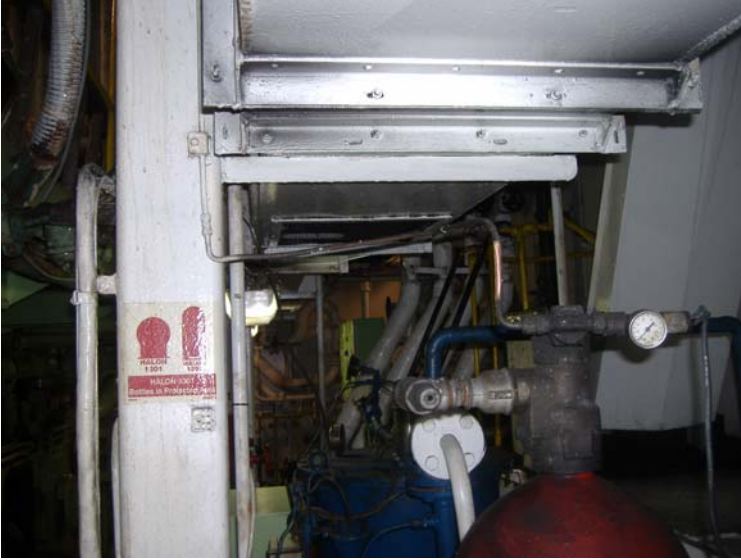
On inspection it was noted that when the Halon 1301 bottles had been changed at some time in the past, the pilot lines which had to be altered to accommodate the new bottles had been re-run in copper, not the manufacturer specified steel. (See Appendix 1, Figure 5).

There was evidence of failures in the copper pilot lines that would have compromised the pilot signal for other Halon 1301 bottles on the same pilot circuit.

Figure 5: Copper pilot lines on Halon 1301 bottles.

- 2 Dobson Fleet Management should inspect:
 - (a) all similar fixed fire fighting systems throughout its fleet and ensure that such systems have not been modified other than in accordance with the manufacturer's specifications and in particular to ensure that pilot tubing conforms to the manufacturer's specifications;
