**Interim Report of the investigation of
the accident resulting in one fatality
during anchoring operations on board the private yacht**

OCEAN VICTORY

**in Koh Tachai, Thailand
on 13 March 2016.**

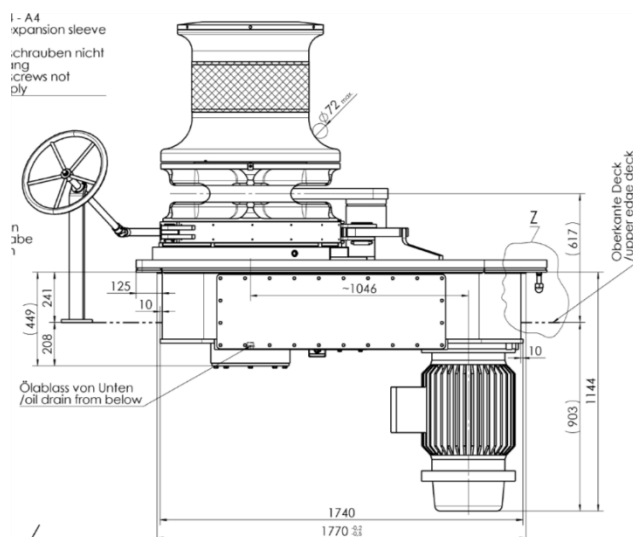
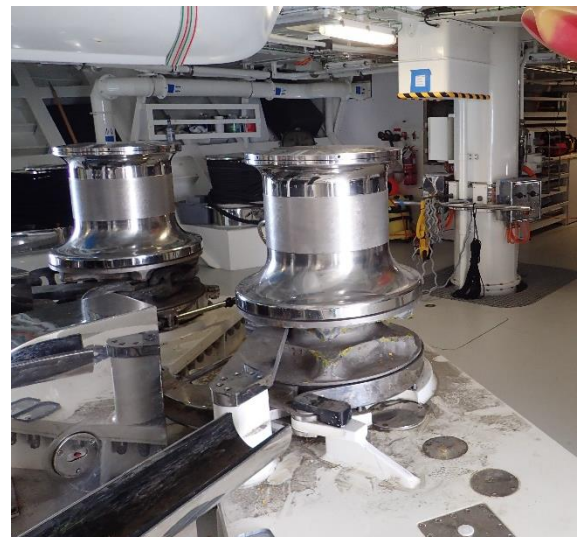
Figure 1 & 2: Anchor windlass

The anchor windlasses on board OCEAN VICTORY of twin vertical access windlass and capstans; as shown in figures 1 and 2.

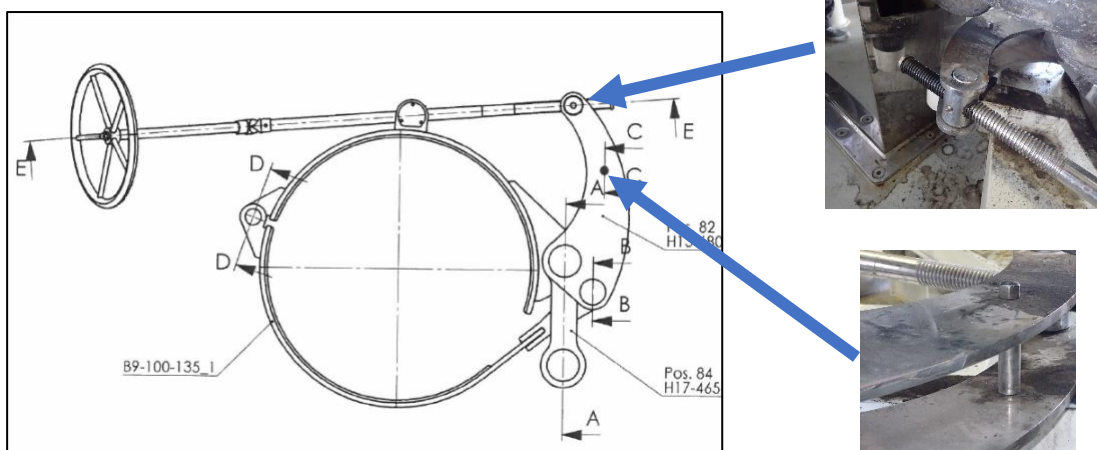
Figure 3: Windlass Brake

The windlass brake consists of a band of friction material running around the circumference of the anchor windlass. The force applied by the brake is controlled by a hand wheel which tightens the friction material onto the brake drum, as shown in figure 3.

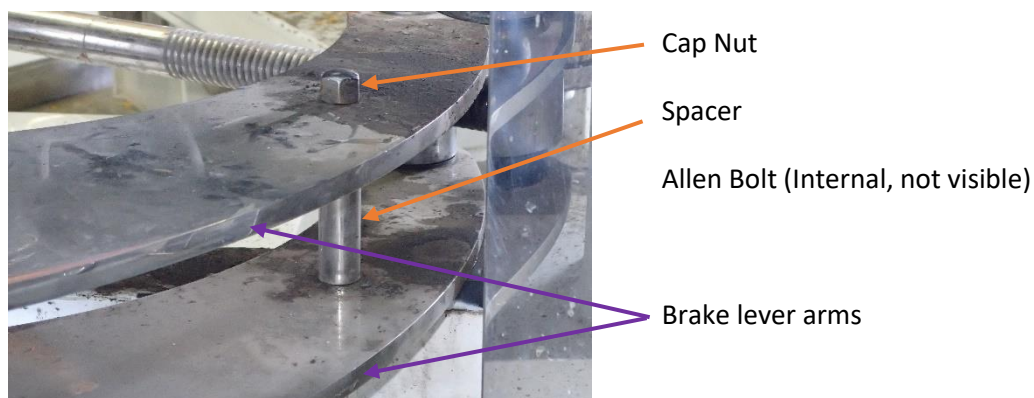
Figure 4: Cap nut, spacer and bolt arrangement

Prior to the accident occurring, the integrity of the brake mechanism was maintained by a single cap nut, allen bolt and spacer arrangement which held the upper and lower brake lever arms in place. (See figure 4).

While dropping the anchor, the cap nut became detached from the allen bolt and integrity of the braking system was lost. Without the nut, spacer and bolt arrangement in place the brake lever arms moved apart and the brake hand wheel and shaft became detached from the braking mechanism. With the brake wheel and shaft detached from the lever arms, the brake could not function and there was no other method of effectively controlling the speed of the anchor chain.

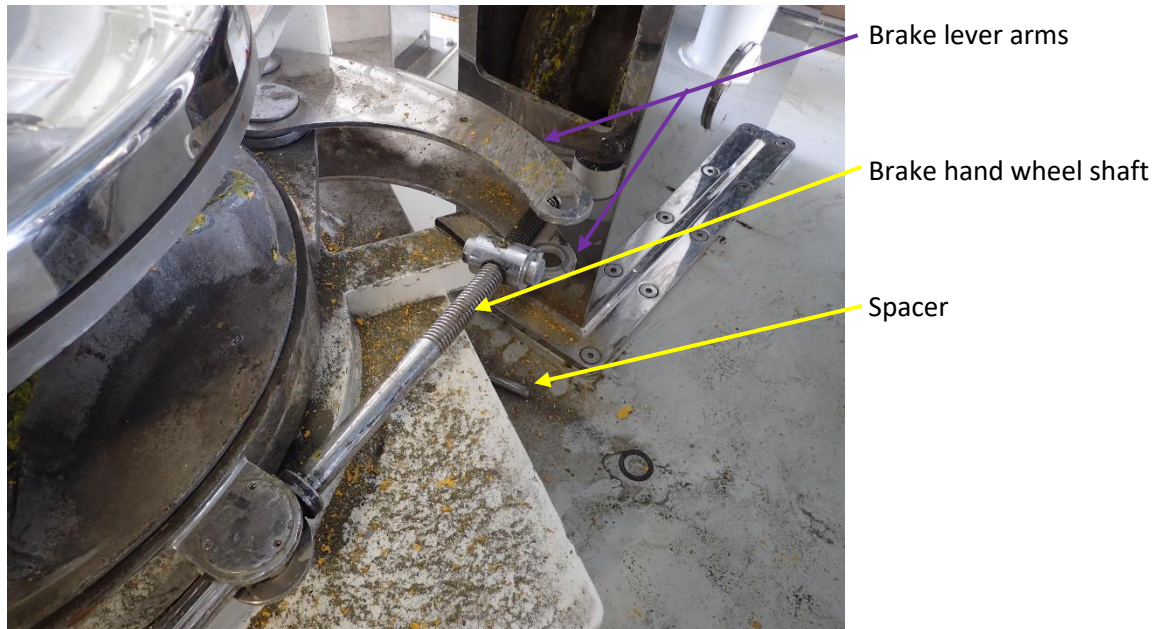
Figure 5: Brake arrangement after failure

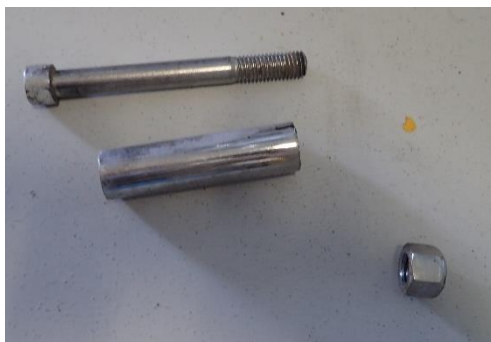
The cap nut, spacer and allen bolt were recovered after the accident and, rather than a failure of any single component, it was found that the cap nut had unscrewed from the allen bolt.

Figure 6: Cap nut, spacer and allen bolt, as recovered.
