Issued May 13, 2022

MIR-22/16

Engine Room Fire aboard Yacht *La Dolce Vita*

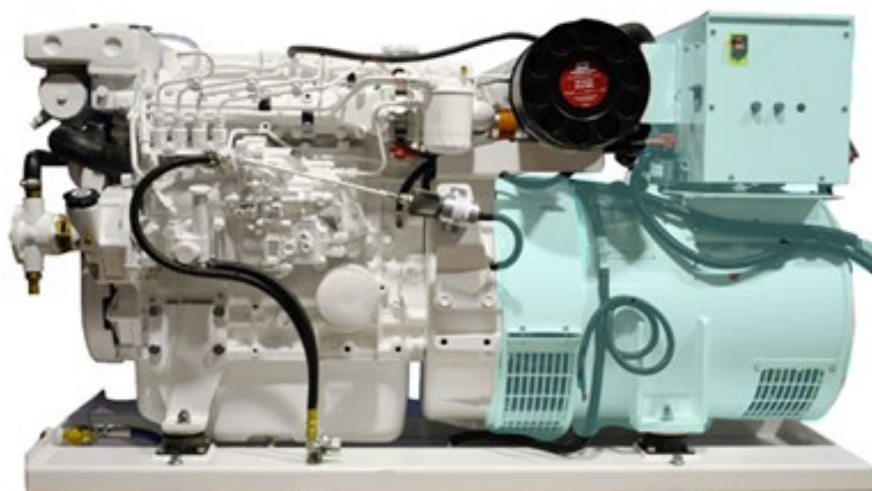
Figure 3. Northern Lights model M944T3 genset highlighting the electrical generator (blue, right) and the diesel engine (white, left), shown without sound enclosure. (Source: Northern Lights)

The captain and mate described the odor of the smoke coming from the starboard generator like burning plastic and like the insulation from wires burning; the captain told investigators that it did not smell like a fuel-fed fire. This, combined with the captain's and mate's descriptions of where the smoke and flames emanated, suggests that the fire may have originated in the electric generator end of the starboard genset enclosure. However, due to the extent of the fire damage, investigators were unable to conclusively determine the source of the fire within the genset enclosure.

Investigators considered likely causes of an electrical issue with the genset that could have led to the fire. The engine room's moisture eliminator vents, as fitted, could trap water droplets that were 10 microns or greater—but this would not eliminate water mist (classified by the manufacturer as particles generally smaller than 10 microns). Unfiltered mist particles in the moist air brought into the engine room could lead to high humidity in the space. The generator manual warned that it was dangerous to operate the generator for extended periods in an area of high humidity. The generator manual also recommended maintenance to keep the unit free of oil, dust, and moisture, and inspecting the voltage regulator periodically to make sure electrical connections were tight and free of moisture and dust. However, the vessel owners did not have documentation of any maintenance to the generator since its installation, so it is possible that loose, moist, or dusty connections went undetected and caused arcing in the AVR or other genset electrical component. Such arcing could have caused the wire insulation to burn, leading to the smoke and flames that the captain observed.

The National Transportation Safety Board determines that the probable cause of the engine room fire aboard the yacht *La Dolce Vita* was an undetermined electrical source within the sound enclosure for the starboard generator. Contributing to the severity of the fire and total loss of the vessel was the inability to secure ventilation to the engine room, which reduced the effectiveness of the yacht's fire extinguishing system and allowed the fire to spread beyond the engine room.

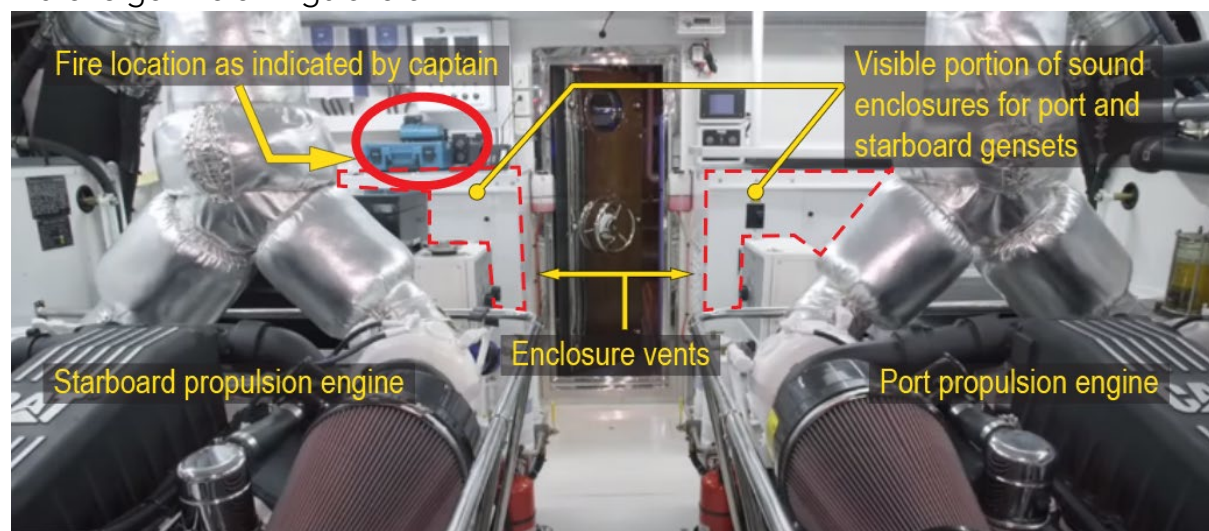
Figure 4. View of *King Baby* (later renamed *La Dolce Vita*) engine room space looking aft toward the engine room door, 2009. (Background source: Cayman Islands Shipping Registry)

To keep the engine room cool while running the generators, the crew ran four 110-volt electric fans, in ducts at the top of the port and starboard bulkheads to the space. Two intake fans on one side brought outside air into the space, and two on the opposite side exhausted air from the space. Electricity to the fans could only be secured at the main electrical switchboard on the forward bulkhead of the engine room.

The only means to start or stop the engine room's intake and exhaust fans was located within the space, and the fans remained running until the captain secured the electrical generators. Further, the engine room vents did not have dampers to close off natural ventilation to the space nor were they required to as a pleasure yacht per the vessel's registry. With no effective way to close all the openings (in this case the vents) before the release of the fire suppressant into the engine room, it is likely the air movement generated by the fire's draft introduced a continuous supply of oxygen into the engine room to feed the fire and hindered the FM-200 from effectively breaking the chain reaction needed to support combustion.

Fixed fire-extinguishing systems in machinery and other hazardous spaces require a minimum concentration of extinguishing agent to either halt the chemical reaction producing the fire, displace the oxygen feeding the fire, or effect a combination of both. To ensure the effectiveness of the system and prevent the reintroduction of oxygen to the space, vessel designers and owners should ensure that the ventilation, both natural and forced draft, can be completely and remotely secured to all fire-protected spaces, and that all machinery within these same fire-protected spaces can be remotely stopped from outside the space where the machinery is situated.

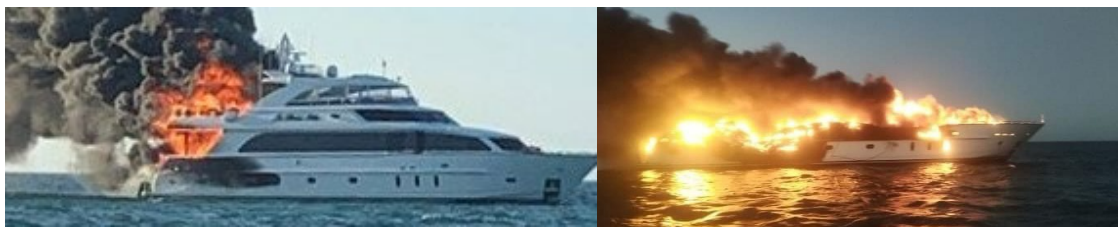
The mate, passengers, and rest of the crew boarded the tender, donned lifejackets, and waited for the captain. The captain made one last trip to the engine room and saw, through the door’s window, flames reaching the overhead. He opened the door and discharged another dry chemical fire extinguisher in the direction of the flames. He told investigators that when he opened the engine room door this last time the fire smelled electrical in nature, “like insulation burning off of electrical wires,” and not like a fuel-fed fire. Believing that he could not save the boat, the captain joined the crew and passengers aboard the tender and took the tender a safe distance off the yacht to await arrival of a Coast Guard response boat. The captain estimated the total elapsed time between when he first noticed the smoke until he abandoned the yacht was no more than 10 minutes. About 15-20 minutes after boarding the tender, flames and dark black smoke could be seen coming from the yacht.

Figure 5. *La Dolce Vita* on fire shortly after passengers and crew abandoned the vessel (left), and the yacht afire shortly after sunset on March 16 (right). (Source: Lindsey Schult, Captain of *La Dolce Vita*)

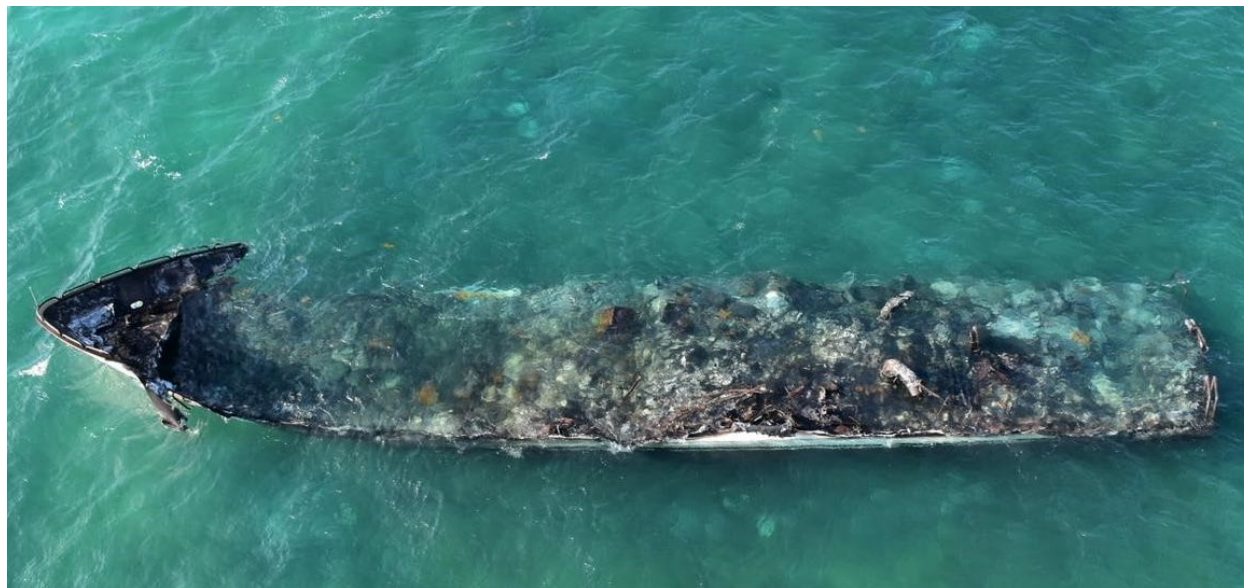
Figure 6. After-fire remains of *La Dolce Vita* before salvage operations. (Source: Coast Guard)

The vessel was deemed a total loss with an estimated value of \$3.9 million. Salvage operations began on March 19. The underwater portion of the hull was lifted with air bags, and other salvaged items were lifted and placed on a barge. The hull was

towed to a marina in Key West, arrived on March 30, was cut into two pieces to facilitate lifting, and was fully ashore by April 2. An inspection by the Coast Guard, owners, and equipment manufacturers followed. Due to the condition of the salvaged items, equipment manufacturers could not determine the cause of the fire.
