FLYER TO THE YACHTING INDUSTRY (01/2023)

Incidents on Gangways, Pasarells and Accommodation Ladders.

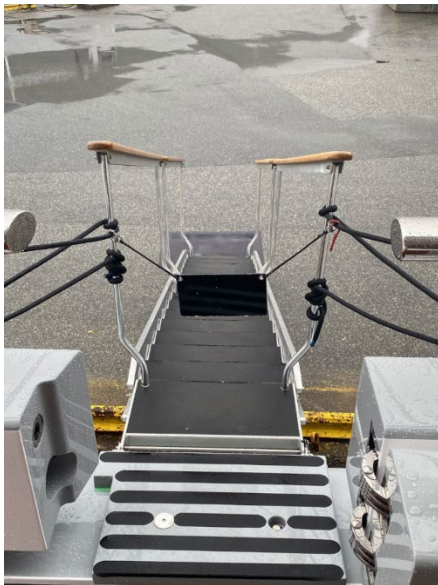
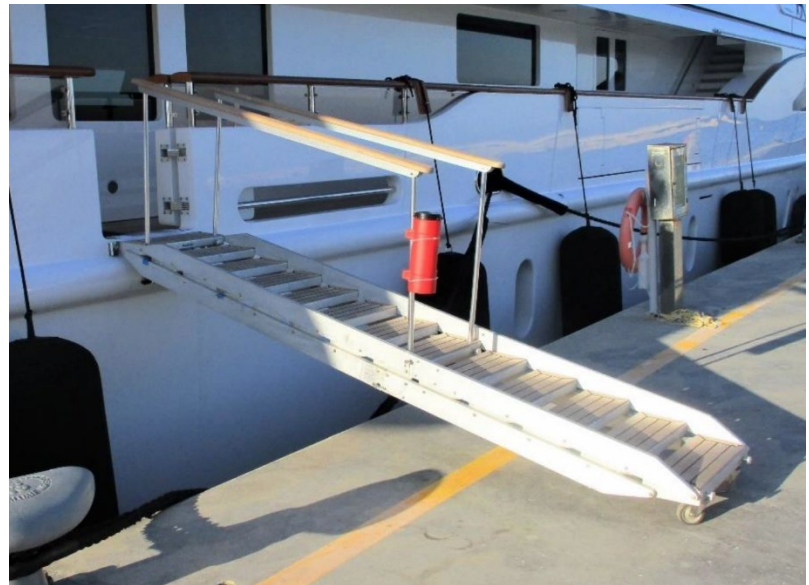
Over recent years, a number of incidents have been reported to the Maritime Authority of the Cayman Islands (MACI) involving persons losing their footing on gangways, passarells and accommodation ladders. Each of these incidents involved a means of access to the yacht which was not provided with intermediate railings or other means to prevent a person falling outside of the gangway or pasarelle.

(Examples of yacht gangways without intermediate railings)

To prevent further accidents, the REG Yacht Code was amended in December 2020 to require gangways, passarells and accommodation ladders to be provided with protection against falling overboard as follows –

“Side screens or handrail(s) shall be provided on both sides and shall comply with one of the following options:-

(a) Where handrails are provided these shall be supported by stanchions at intervals of not more than 2200mm. Intermediate rails or wires shall also be provided. The opening below the lowest course of the Intermediate rails or wires shall not exceed 230 mm. The other courses shall be not more than 380 mm; or

(b) Intermediate rails and toe boards (which may be portable) are to be provided in accordance with ISO 7061:2015, Figure 1 – General Arrangement of a Gangway Type A”.

Evaluate all means of access to the yacht against the current REG Yacht Code requirements for stanchion distances and intermediate handrails.

Any means of access not in compliance with current requirements should not be used until modified to comply with these requirements or replaced with a compliant means of access.
