URGENT SAFETY RECOMMENDATIONS

FLYER TO THE YACHTING INDUSTRY (05/2023)

Failure of “Side Boarding Ladders” attached to yacht hulls.

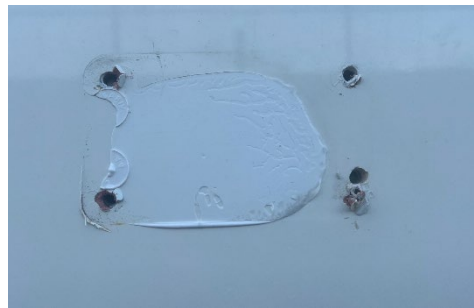
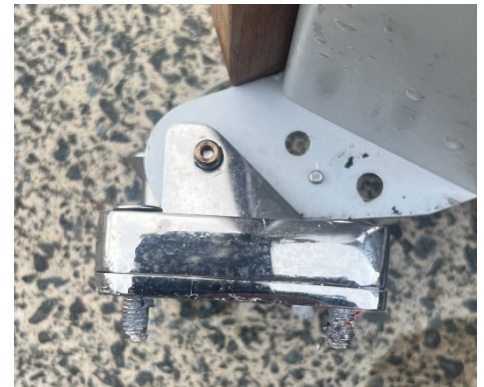
Photographs:

An examination of photographs taken after the incident showed that –

The bolts securing the mounting bracket of the side boarding ladder only extended approximately 15mm from the bracket and did not engage with any doubling plate that may have been fitted;

The mounting bolts were only “engaged” in the fairing compound and pulled out of the fairing compound during the incident;

The threads of the mounting bolts were not “stripped” during the pull out; and

The side boarding ladder did not comply with the REG Yacht Code with respect to intermediate rails or wires. See Safety Flyer “[Incidents on Gangways, Pasarellas and Accommodation Ladders](#)”.

Such side boarding ladders should be REMOVED FROM SERVICE until –

all parts of the side boarding ladder (including and “hardware” and fittings) have been visually examined for defects by a competent person; and

a competent person is satisfied that all attachment arrangements to the yacht's hull are fit for the intended purpose. This should include the removal of any screwed attachment to ensure that attachment hardware is of sufficient size and strength that properly and securely attaches the side boarding ladder to the hull.

It is recommended that side boarding ladders are subject to the same examination and load testing regime as pasarells and other gangways. All load tests, including post-installation tests, should be witnessed by the vessels Class Society.
