**Report of the investigation of
the fatality onboard the chemical tanker**

STOLT HELLULAND

**in Houston, Texas
on 13 January 2008.**

Casualty 01/2008

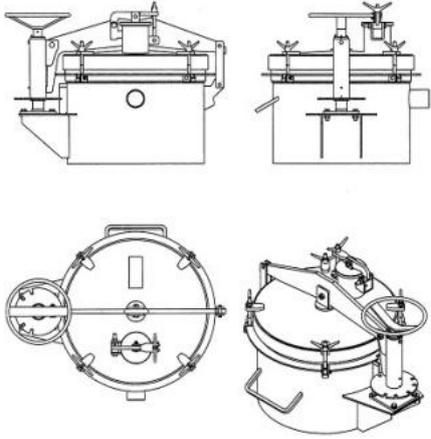
Figure 1: Typical Ullage Hatch

At 0645 the third officer announced that he was going to check the oxygen level in 2 *Stb* and left the CCR and proceeded onto the deck. This operation involves passing a sample tube attached to an oxygen analyser (Figure 3) about 1 ½ meters into the tank and sampling the atmosphere. The tube is passed through the gap in a partially open ullage hatch (Figures 1 and 2).

The chief officer proceeded to 2 *Stb* with the ship's oxygen resuscitator and takes charge at the scene. He noted that the ullage hatch was fully open and on deck beside the hatch was the third officers safety helmet, VHF radios¹ and the oxygen analyser used to test the atmosphere in the tank. Rescue equipment had also been brought to the scene and the duty AB and the pumpman were erecting the rescue tripod over the ullage hatch. Other emergency response equipment at the scene included a rescue breathing apparatus², an oxygen resuscitator and a tank ventilator.
