CAYMAN ISLANDS SHIPPING REGISTRY

FLYER TO THE LARGE YACHT INDUSTRY

Fatal accident while launching Personal Water Craft.

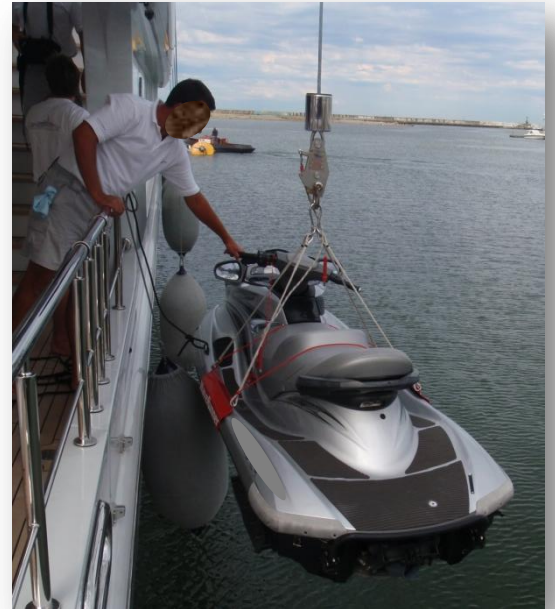
Upon inspection, the steel lifting slings in use were found to have failed in way of the crimped eye connection to the spreader beam. The slings were found to be heavily corroded and this corrosion had not been identified by the onboard maintenance and inspection regime. Further, the history and origin of the lifting sling was not readily apparent. It was stated that they were supplied with the PWC, but the model and manufacturer of the sling could not be identified and no manufacturer's documentation of certification could be located.

- Loose gear should be visually inspected before each use and be integrated into the onboard maintenance, inspection and testing regime.
- Examinations of lifting appliances and loose gear should be carried out by persons competent, by virtue of their knowledge and experience, to do so.

- When visually inspecting loose gear, sufficient areas under tape and other “protective coverings” should be inspected such that the overall condition of the loose gear can be assessed.
