SAFETY BULLETIN

**WARNING: IMPORTANT WATER MIST
FIRE SUPPRESSION SAFETY NOTICE**

Number 004/2017

**HI-FOG® 1900 SPRINKLER
WITH
A1000 TYPE ASSEMBLY BODY WITH STOP VALVE
IDENTIFICATION AND CORRECTION PROCEDURE**

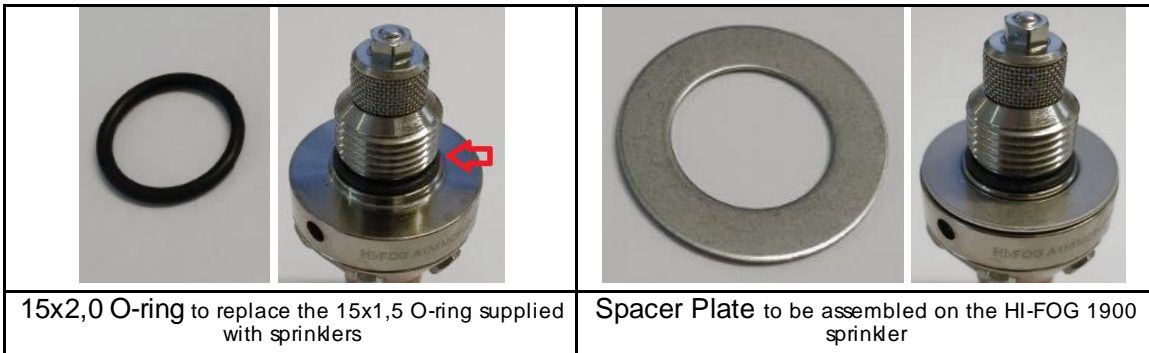
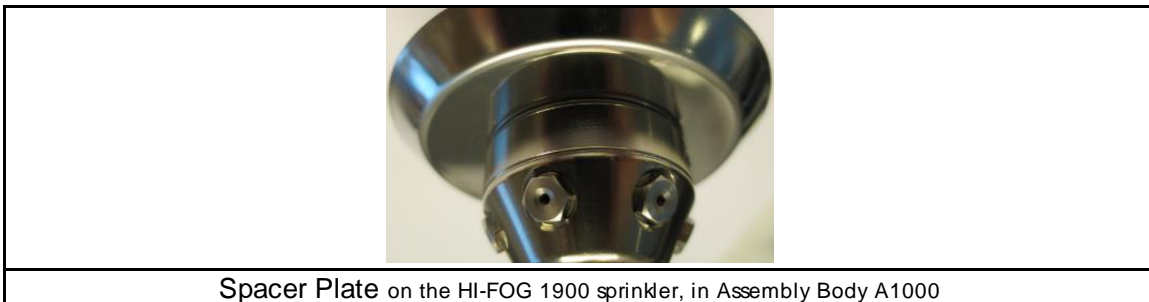
To assure compatibility of HI-FOG 1900 sprinklers with all Assembly Body types, each HI-FOG 1900 sprinkler installed in an affected A1000 type Assembly Body should have the 15x1,5 O-ring replaced with a 15x2,0 O-ring and a Spacer Plate (Marioff Item Code 2000267114) should be installed between the sprinkler and the Assembly Body cover plate. If there is no cover plate, the spacer is to be installed between the sprinkler and the Assembly Body. Follow Marioff instructions (Document number 0003301084) when carrying out the field action.

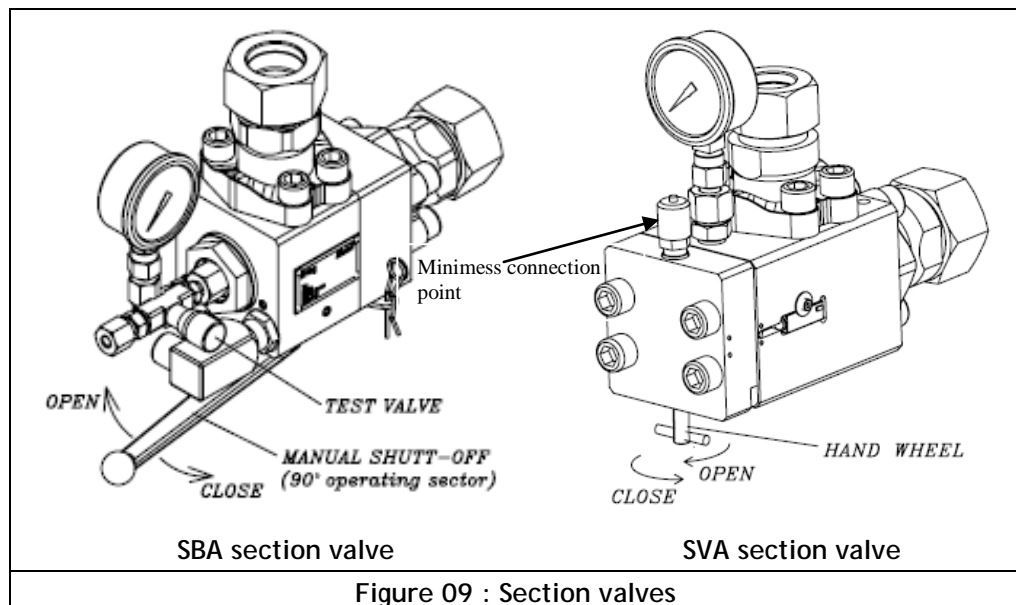
Figure 09 : Section valves

- a. Before depressurizing the section, make sure the section where corrective actions are being carried out is isolated by closing the section valve as illustrated below. (see **Figure 09**).

Note: Use your hands only to manually open or close the valve. Excessive force is not required and should not be used.

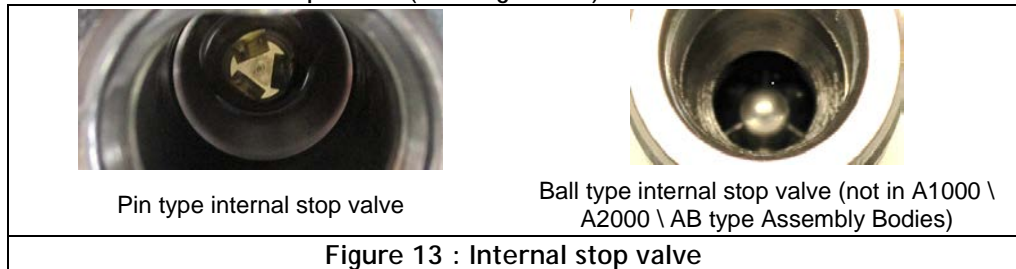
If the type is A1000 then verify from the inside of the assembly body if there is an internal stop valve (see Figure 13).

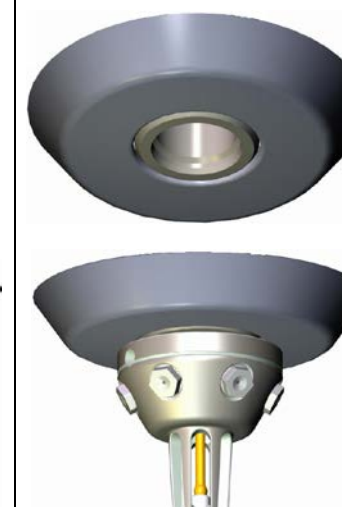
<p>HI-FOG 1900</p> <p>Appearance:</p> <ul style="list-style-type: none"> - Cone shape - Groove above the cone 	<p>HI-FOG 1000</p> <p>Appearance:</p> <ul style="list-style-type: none"> - Cone shape - No groove 	<p>HI-FOG 2000</p> <p>Appearance:</p> <ul style="list-style-type: none"> - No cone - No groove 	<p>HI-FOG 3000</p> <p>Appearance:</p> <ul style="list-style-type: none"> - No cone - No groove
Action Required	No Action Required		
Figure 02 : HI-FOG sprinkler types

- a. HI-FOG 1000 sprinkler have a similar conical shape as the HI-FOG 1900, but the **HI-FOG 1900 has a groove above the conical section** while the HI-FOG 1000 does not.
- b. HI-FOG 2000 and HI-FOG 3000 sprinklers do not have a conical section
- c. Other types, such as pop-up or machinery-space open spray-heads, that are not included in the illustration below, do not have a glass bulb.

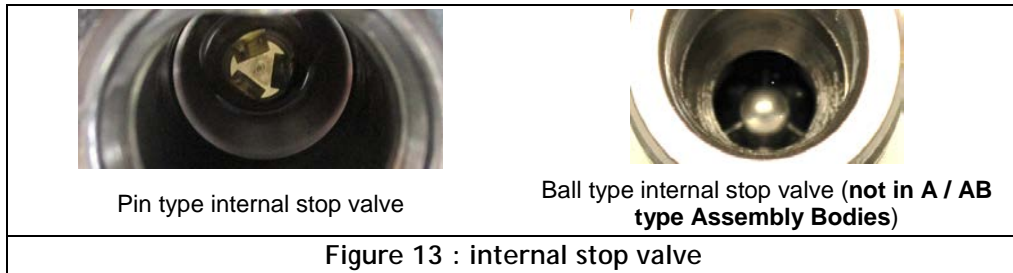
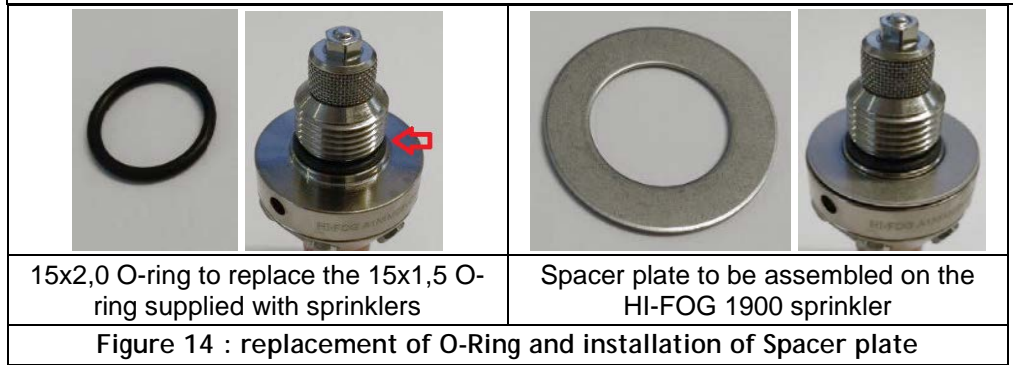
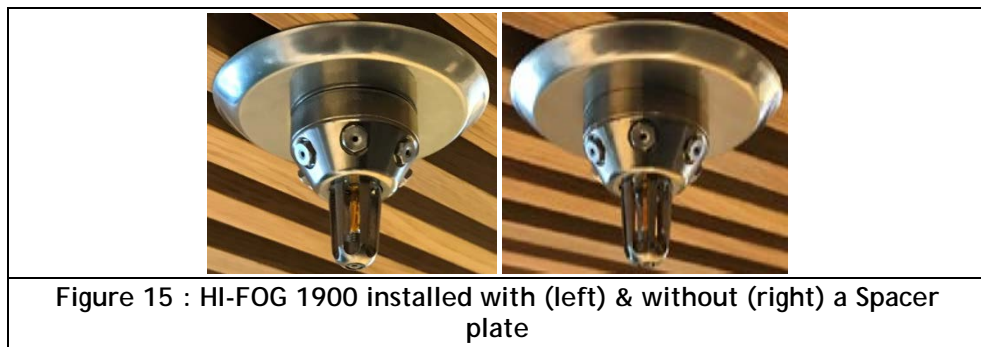
<p>A1000 types</p> <p>Notes:</p> <ul style="list-style-type: none"> - Cover plate supported by the sprinkler : no gap 	<p>A2000 types</p> <p>Notes:</p> <ul style="list-style-type: none"> - Cover plate supported by the sprinkler : not applicable for HF1900 	<p>AB types</p> <p>Notes:</p> <ul style="list-style-type: none"> - Plate supported by snap-ring : gap or spacer 	<p>C types</p> <p>Notes:</p> <ul style="list-style-type: none"> - Cover plate snapped to the Assembly Body with a lock ring : gap
Action Required for HI-FOG 1900	No Action Required		
Figure 03 : Assembly Body types

- a. **With the A1000** type Assembly body there is no gap between the HI-FOG 1900 sprinkler and the cover plate when the HI-FOG 1900 sprinkler is installed (see **Figure 01**). The cover plate (see **Figure 01**) of **A1000 Assembly body** types is held in place by the sprinkler.
- b. The **A2000 Assembly body** type is suitable only for HI-FOG 2000 sprinklers (see **Figure 02** for sprinkler types).
- c. A HI-FOG 1900 sprinkler installed in an **AB** type Assembly body would either leave a 2 – 3 mm gap between the top of the sprinkler and the cover plate, or would have an adaptor ring filling the gap.

See **Figure 03** for AB types below – left half without adaptor ring and right half with adaptor ring. The cover plate of **AB** type is connected to the Mounting Adaptor with a lock ring.

- d. The **C** type the installation with HI-FOG 1900 sprinkler would leave a narrow gap between the top of the sprinkler and the cover plate - The cover plate of **C** type is snapped directly to the Assembly body.
