GUIDANCE NOTE 08/2017 (Rev 1.0)

MARIOFF HI-FOG SAFETY BULLETIN

Number 004/2017

**HI-FOG® 1900 SPRINKLER
WITH
A1000 TYPE ASSEMBLY BODY WITH STOP VALVE
IDENTIFICATION AND CORRECTION PROCEDURE**

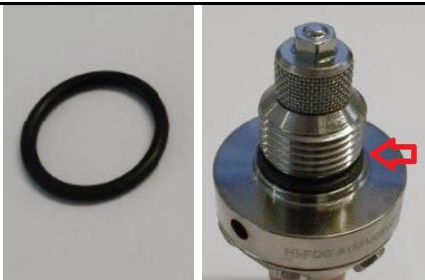
15x2,0 O-ring to replace the 15x1,5 O-ring supplied with sprinklers

To assure compatibility of HI-FOG 1900 sprinklers with all Assembly Body types, each HI-FOG 1900 sprinkler installed in an affected A1000 type Assembly Body should have the 15x1,5 O-ring replaced with a 15x2,0 O-ring and a Spacer Plate (Marioff Item Code 2000267114) should be installed between the sprinkler and the Assembly Body cover plate. If there is no cover plate, the spacer is to be installed between the sprinkler and the Assembly Body. Follow Marioff instructions (Document number 0003301084) when carrying out the field action.

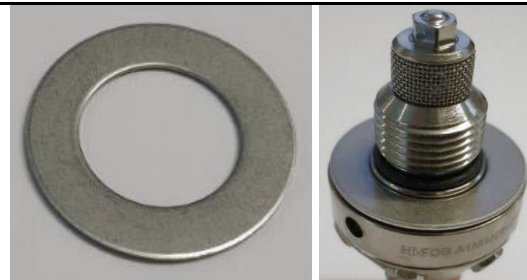
Spacer Plate to be assembled on the HI-FOG 1900 sprinkler

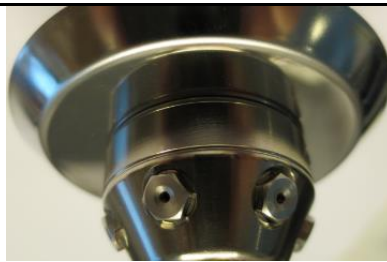
Spacer Plate on the HI-FOG 1900 sprinkler, in Assembly Body A1000

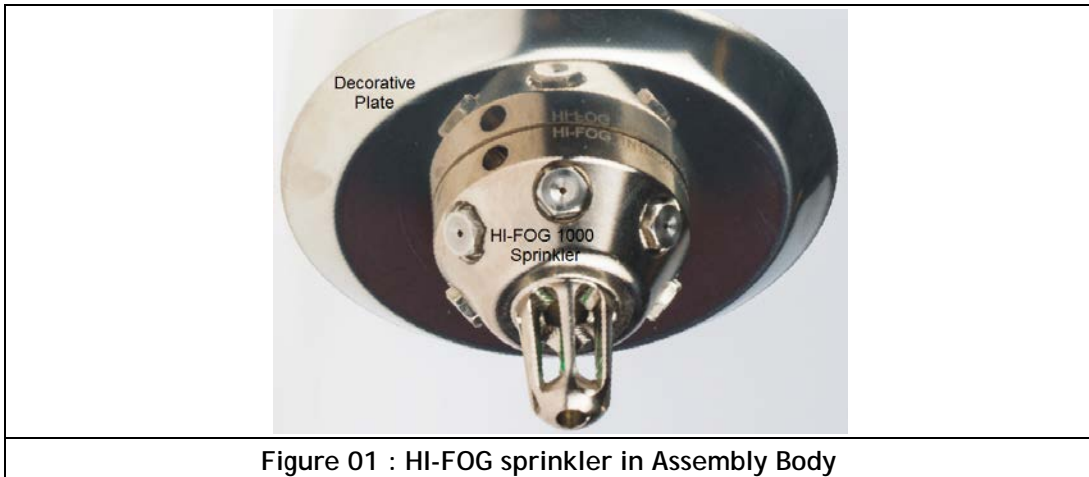
Figure 01 : HI-FOG sprinkler in Assembly Body

Installation of HI-FOG sprinklers consists of HI-FOG sprinkler inserted into a specifically built Assembly Body, also known as 'Mounting Adaptor'.

The A1000 Assembly Bodies were built to accommodate the HI-FOG 1000 sprinklers. Some types of this Assembly Body include an internal stop valve that prevents the flow through the Assembly Body if the sprinkler is removed.

For some of the Assembly Body type A1000, there is a risk that a HI-FOG 1900 sprinkler will press the internal stop valve beyond the intended range and thus may diminish or in the worst case prevent the water flow to the sprinkler in case of discharge.

- a. **With the A1000** type Assembly body there is no gap between the HI-FOG 1900 sprinkler and the cover plate when the HI-FOG 1900 sprinkler is installed (see **Figure 01**). The cover plate (see **Figure 01**) of **A1000 Assembly body** types is held in place by the sprinkler.
- b. The **A2000 Assembly body** type is suitable only for HI-FOG 2000 sprinklers (see **Figure 02** for sprinkler types).
- c. A HI-FOG 1900 sprinkler installed in an **AB** type Assembly body would either leave a 2 – 3 mm gap between the top of the sprinkler and the cover plate, or would have an adaptor ring filling the gap.

Assembly Body type A1000 with or without cover plate (see Figure 01) needs to be addressed in the same manner.

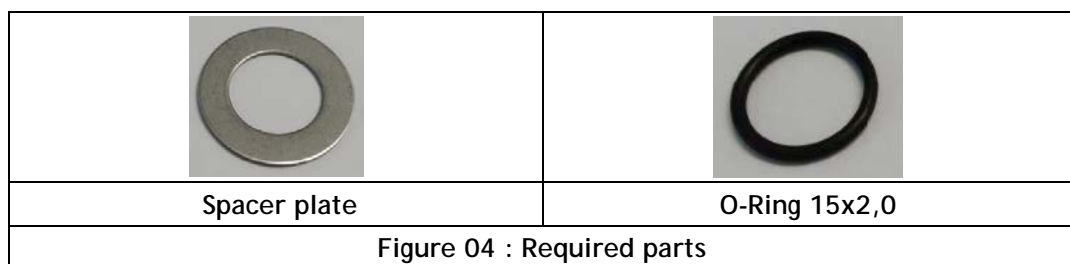
- Spacer Ring, Marioff item code 2000267114
- O-Ring 15x2,0, Marioff item code 2000297566

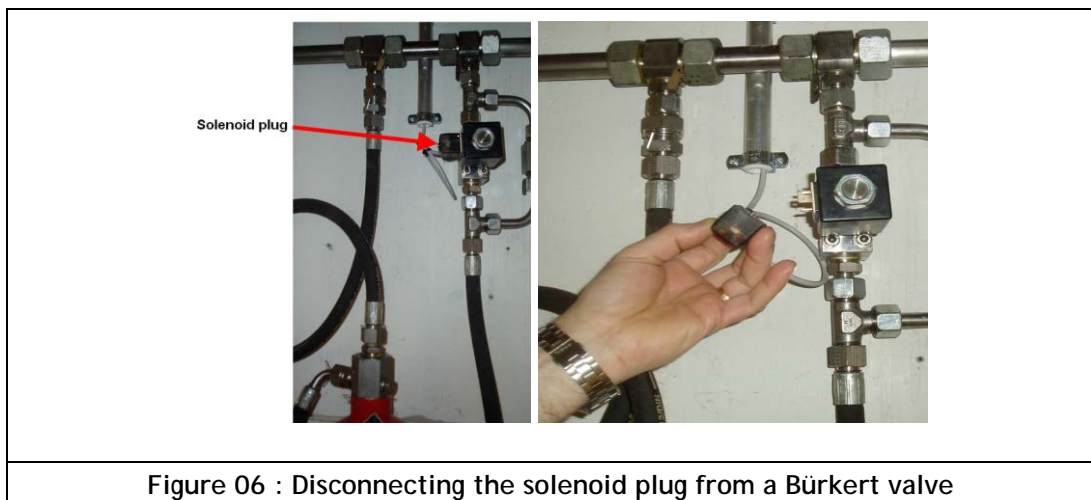
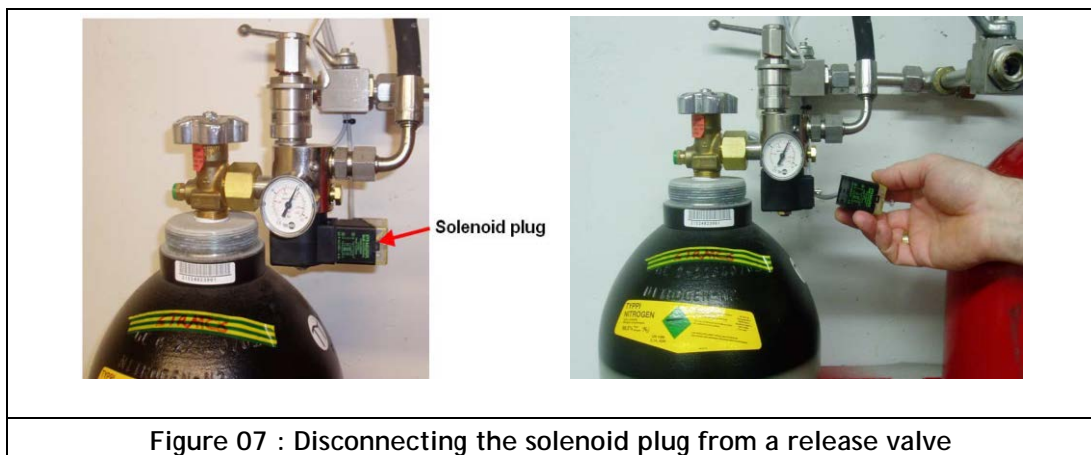
Before starting corrective actions, switch on the Nitrogen blocking from the key switch on the control panel or disconnect the nitrogen accumulator unit (if applicable) to avoid the accidental release of nitrogen (see Figure 06 and Figure 07).

After finalizing the corrective actions in all sections, the system should be put back into normal standby mode and the nitrogen accumulator unit should be switched back on / reconnected. (see Figure 06 and Figure 07).

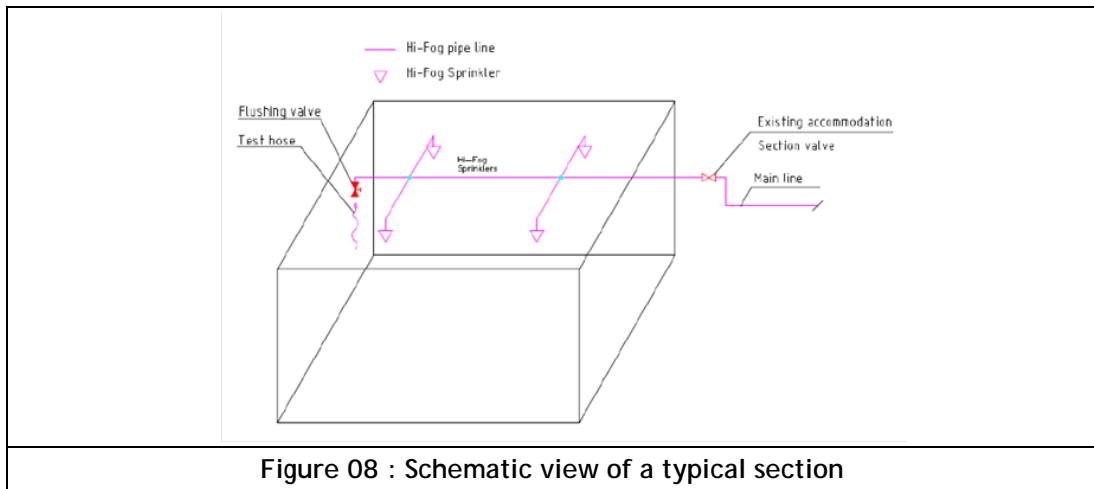
Figure 08 : Schematic view of a typical section

Figure 08 illustrates the schematic view of a typical section:

Before removing the sprinklers it is advisable to isolate (see **a** below) and depressurize the section where the HF1900 sprinklers will be modified to minimize the risks of spillage and false starting of the pump unit.

Depressurizing the section can be done either from the Flushing Valve (see **b** below) or from the Section Valve (see **c** below).

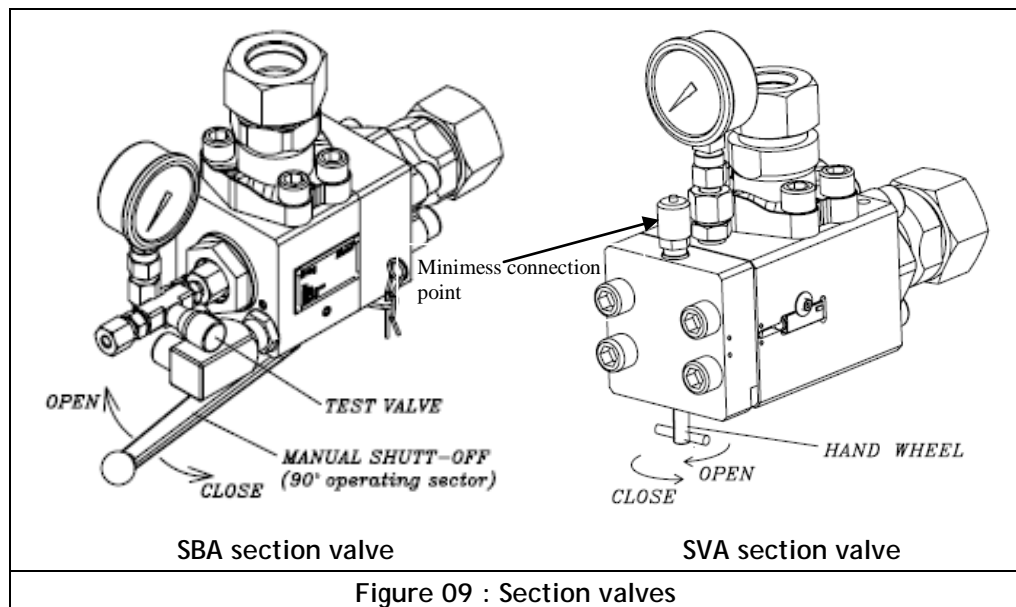
Figure 09 : Section valves

- a. Before depressurizing the section, make sure the section where corrective actions are being carried out is isolated by closing the section valve as illustrated below. (see **Figure 09**).

Note: Use your hands only to manually open or close the valve. Excessive force is not required and should not be used.

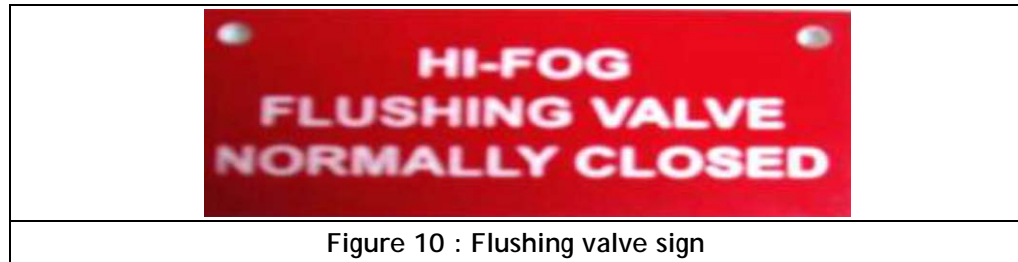
Figure 10 : Flushing valve sign

- b. The section can be depressurized from the flushing valve with a flushing hose (see Figure 05). The flushing valves of the sections should be marked on the HI-FOG sprinkler layout drawings. Flushing valves are equipped with a flushing valve sign (see Figure 10).

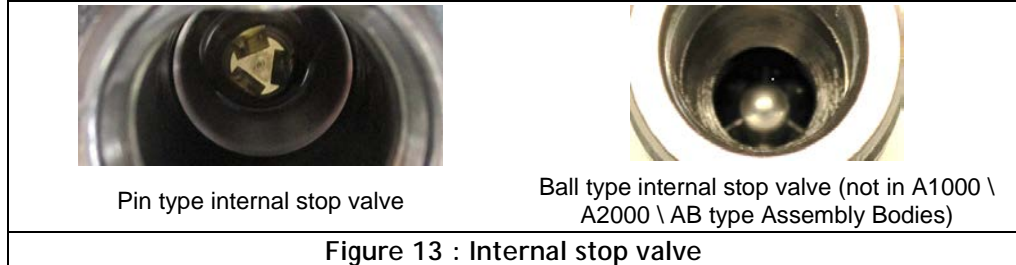
If the type is A1000 then verify from the inside of the assembly body if there is an internal stop valve (see Figure 13).

Log the type and existence \ absence of internal stop valve in the follow up sheet (see Figure 12).

If there is **NO** internal stop valve, reinstall the sprinkler (go to step **g** below).
If the type is A1000 AND there IS an internal stop valve then continue:

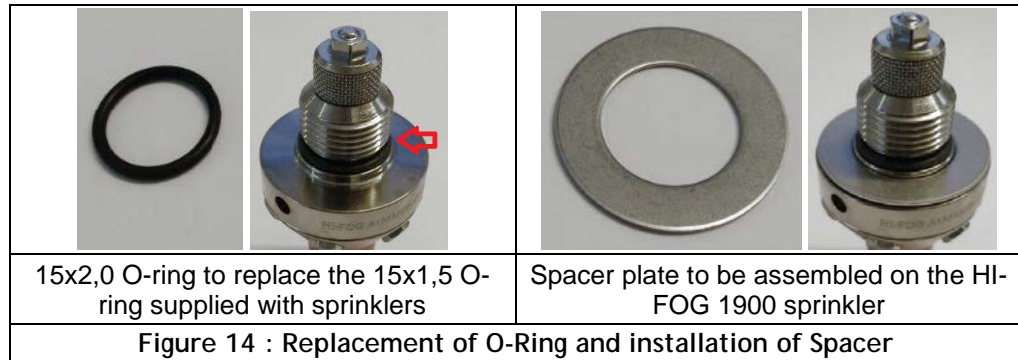
- e. Remove the 15x1,5 O-ring from the sprinkler (see Figure 14). Do not damage or scratch the sprinkler's sealing surface. Cut the removed O-Ring to assure it does not mix with the new seals.

- f. Install the new 15x2,0 O-ring to the sprinkler by placing the O-ring installation cone (see Figure 05) over the spindle and rolling the new O-ring onto the sprinkler until you are sure the O-ring sits correctly in its groove (see Figure 14).
- g. Install the spacer to the sprinkler (see Figure 14).

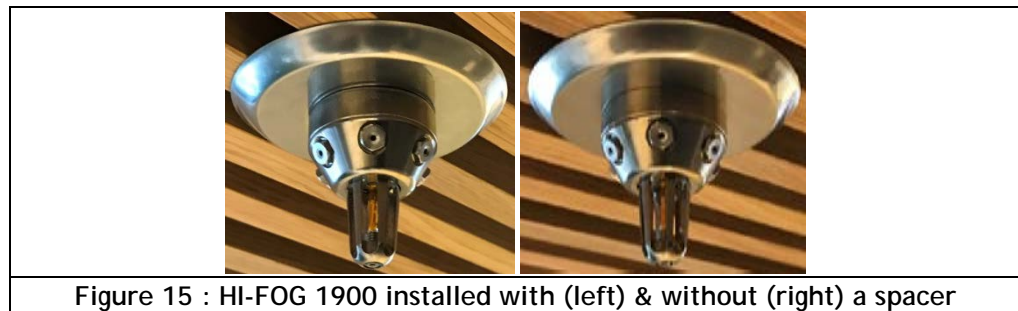
- h. Install the sprinkler and the cover plate back into place. Tighten it with the sprinkler key. Do not use excessive force.

- Is a cover plate (see Figure 15) present (yes/no)
- Date of changing the O-Ring \ installing the spacer plate

NOTE: Do not use excessive force when tightening the sprinkler to avoid damaging the sprinkler.

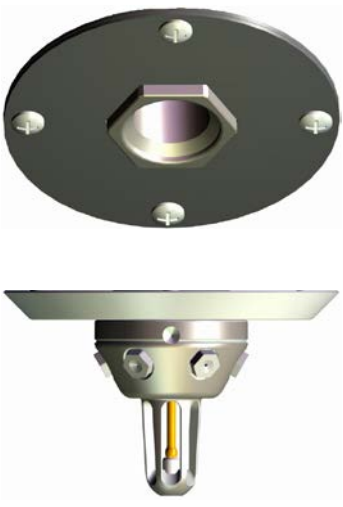
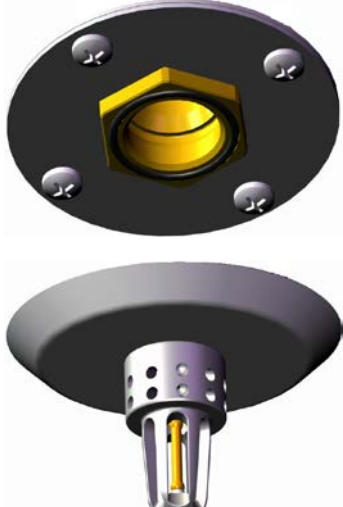
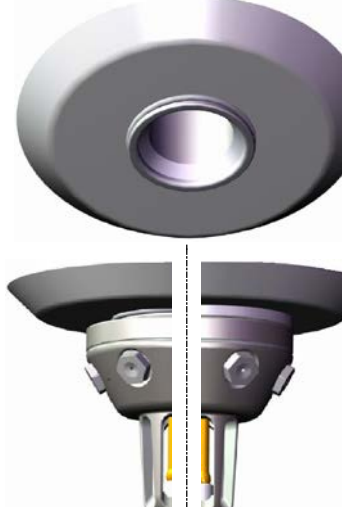
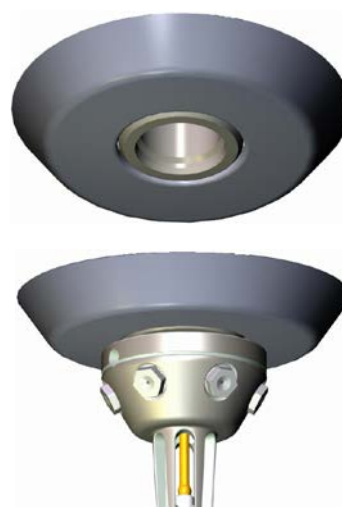
<p>HI-FOG 1900</p> <p>Appearance:</p> <ul style="list-style-type: none"> - Cone shape - Groove above the cone 	<p>HI-FOG 1000</p> <p>Appearance:</p> <ul style="list-style-type: none"> - Cone shape - No groove 	<p>HI-FOG 2000</p> <p>Appearance:</p> <ul style="list-style-type: none"> - No cone - No groove 	<p>HI-FOG 3000</p> <p>Appearance:</p> <ul style="list-style-type: none"> - No cone - No groove
Action Required	No Action Required		
Figure 02 : HI-FOG sprinkler types

- a. HI-FOG 1000 sprinkler have a similar conical shape as the HI-FOG 1900, but the **HI-FOG 1900 has a groove above the conical section** while the HI-FOG 1000 does not.
- b. HI-FOG 2000 and HI-FOG 3000 sprinklers do not have a conical section
- c. Other types, such as pop-up or machinery-space open spray-heads, that are not included in the illustration below, do not have a glass bulb.
